Almost Schooled by the Florida Pan Handle Soils

RiverCamps on Crooked Creek is a 1,500 acre unique product by The St. Joe Company that was created with the vision of providing its owners the ability to enjoy and discover West Bay. The residential development is located in Northwest Florida's Emerald Coast in Panama City Beach. The JOE community is carefully nestled in a secluded woodland preserve along the sparkling waters of Crooked Creek and the spectacular 18,000 acre expanse of West Bay. Nearly two thirds of RiverCamps has been set aside for conservation. The development consists of 408

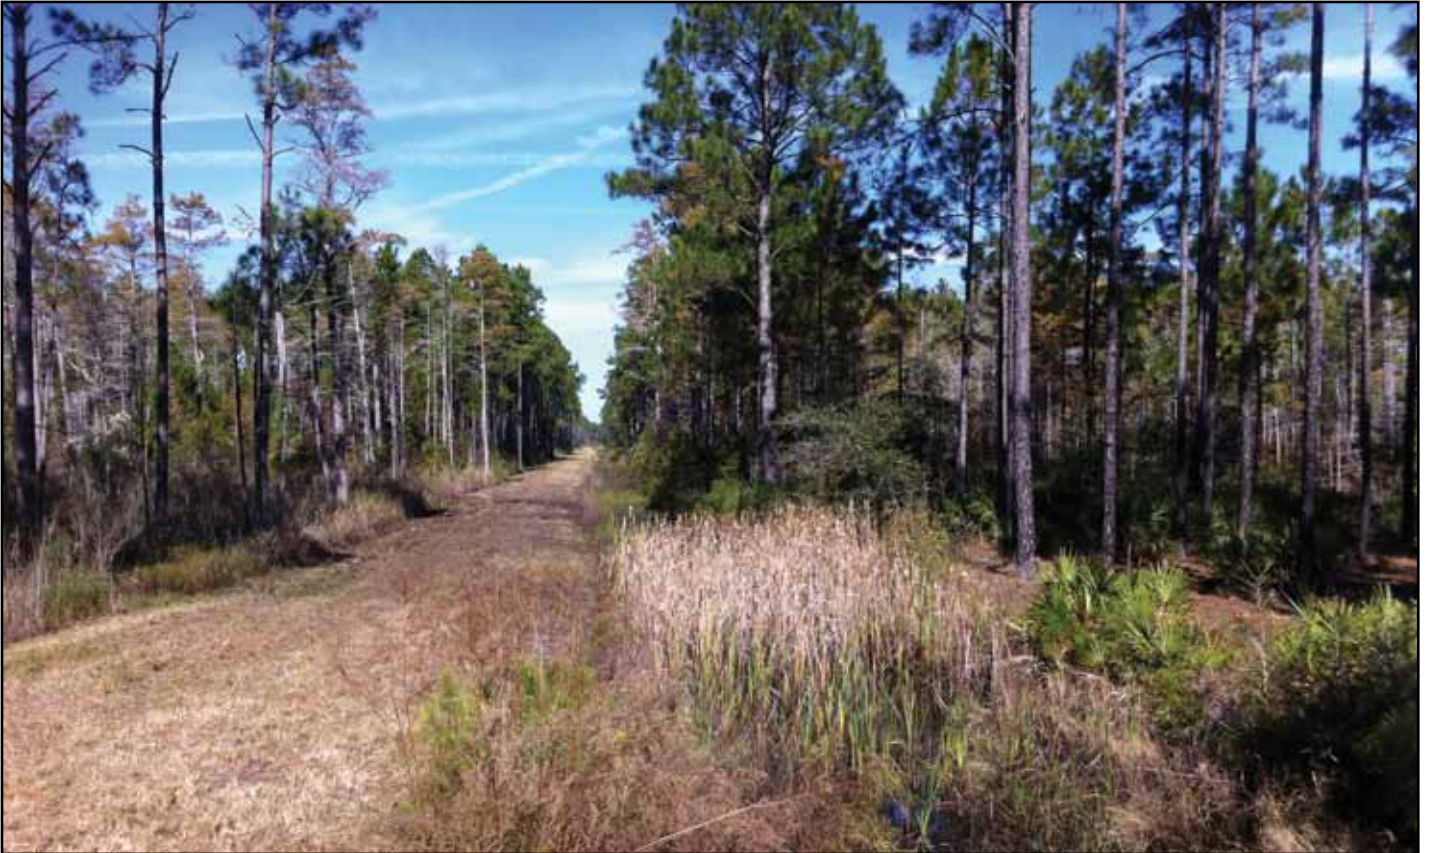
Protected bank today after the erosion control blankets have completed their job of controlling erosion until vegetation has become established.

The Third action was the use of erosion control blankets (ECBs) to prevent soil erosion and hasten vegetation efforts by protecting the seed bed. A single strip of Curlex® II excelsior matting, as provided by American Excelsior Company, Arlington, Texas, was installed along the road curb to prevent erosion along the shoulders. Sod strips were not used as an alternative

along the curb because sod may compete with adjacent native plantings if it becomes established. This matting was selected because of its performance capabilities and extended functional longevity as compared to other erosion control product options. It was also installed along areas where concentrated flow conditions were anticipated or areas that were deemed highly erodible. These areas included the drainage channels and slopes. Curlex ECBs were chosen for these applications because of the “Velcro-like” connection they make with soil. As rain hits the excelsior ECBs the soil beneath is protected and held in place by the wood fiber matrix within the blanket. Rain water is absorbed by the matrix, which aids in vegetation establishment especially during droughty conditions. Moisture is released back to the seedbed from the Curlex fibers as the soil begins to dry. The engineered fibers curl, expand, and interlock with each other when wetted. The engineered denier and curl of the fibers produce a product that intimately intermingles with soil for a period of time that provides a superior performance-based cover factor to prevent erosion and provide beneficial seed bed conditions. In addition, these products
