Freedom Park Stream Restoration Project Repair

by Pete Romocki and Chris Matthews

Note: This original project was written up in Land and Water Magazine in December of 2004.

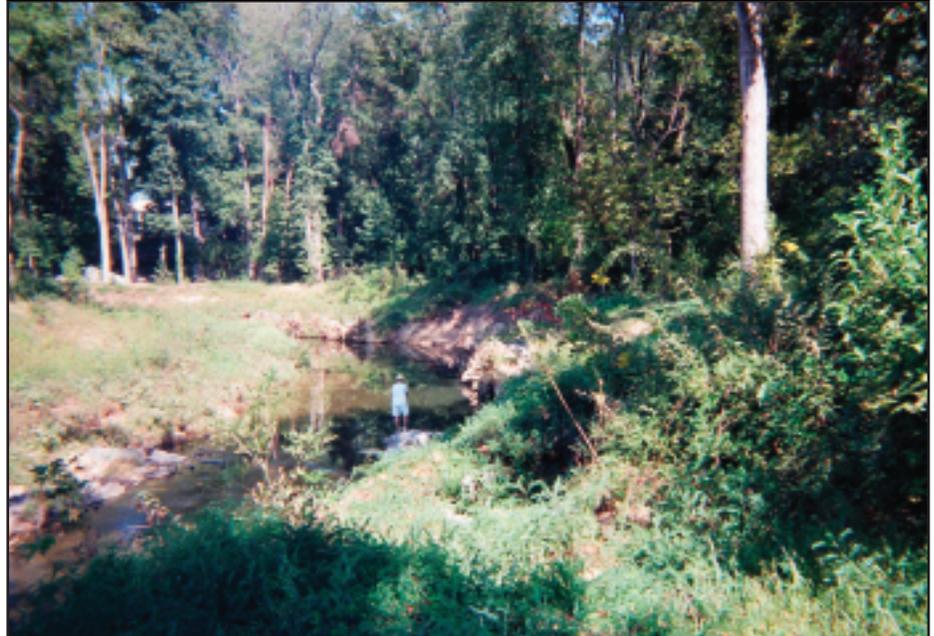
Restored stream project. Photo taken September 2006 by Doug Smith.

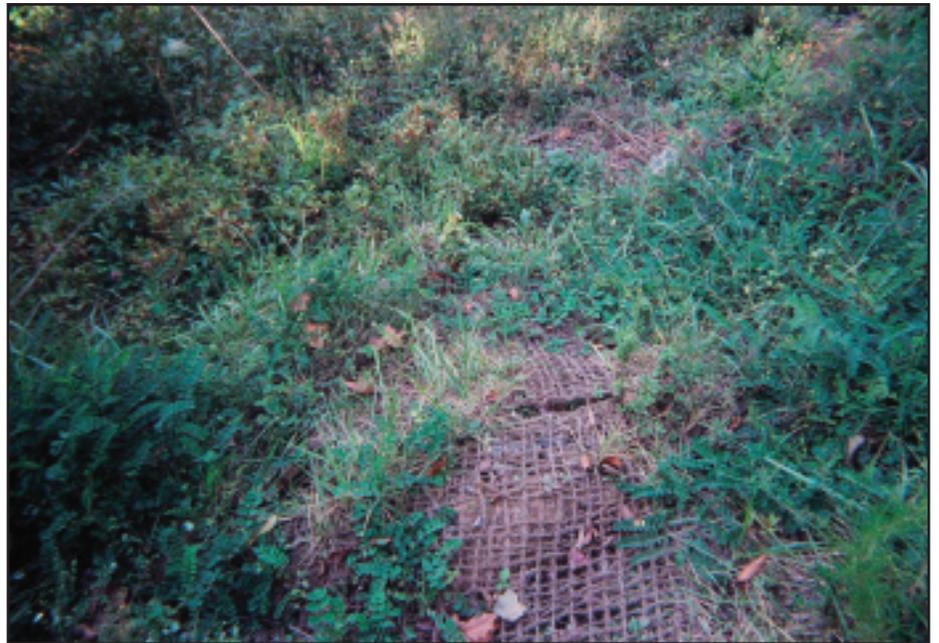
Exposed coir mat where vegetation is still being established. Photo taken 2006 by Doug Smith.

The repair work was completed by a four man crew in about four days by North State Environmental, Inc. They hydroseeded the cleared banks using a browntop millet variety grass seed. The netless excelsior blanket was then installed onto the seeded banks and finally the heavy woven coir matting was laid

The Freedom Park project had strict environmental requirements from HDR to be constructed with materials that were completely biodegradable. This requirement eliminated the option to use traditional TRMs. In the redesign of the failed eroded areas HDR surveyed the marketplace for other available options. Selected was a combination of biodegradable erosion blanket materials. Utilized was a netless excelsior blanket (Curlex NetFree) and a heavy woven 700 gm./sq. meter coir mat used in combination with each other. The coir mat was installed on top of the netless excelsior and both were anchored down using wood one foot long

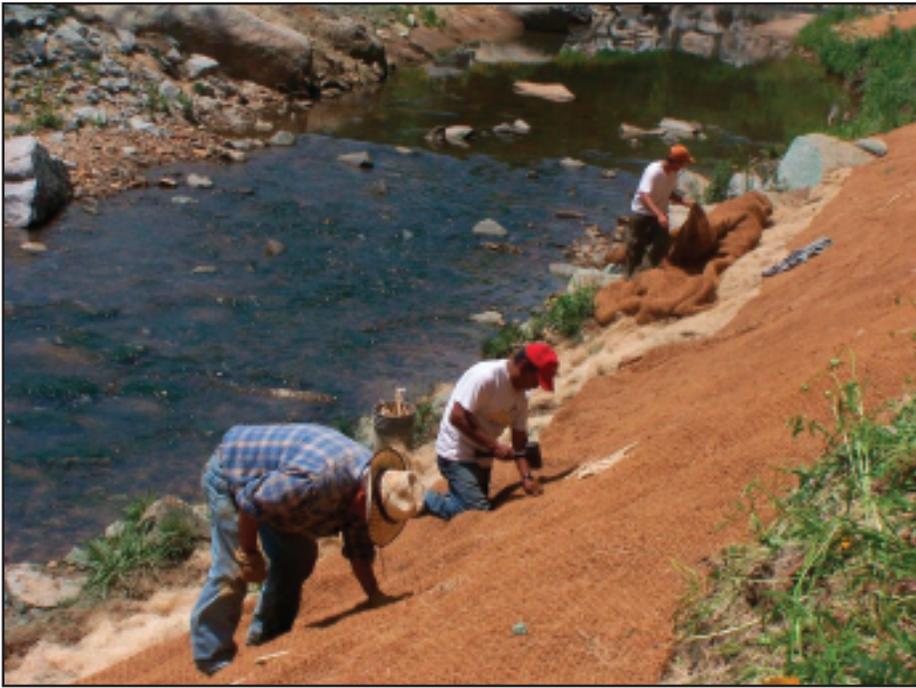
Installation of coir woven mat on top of net free excelsior using one foot long wood stakes. Photo taken May 2005 by Pete Romocki.

down on top of it and staked. The contractor installed the netless excelsior blanket on a large area and had the intention of installing the coir mat over it the next day. Unfortunately a significant storm occurred that evening and damaged the entire area that had been laid. They were able to reclaim most of the netless excelsior fiber, redistribute it and then secure it with coir mat. The lesson learned is to install the coir mat on top of the netless excelsior as soon as possible to prevent damage.

Significant rain had also occurred less than 10 days after the installation and the repaired areas appeared to have held up good during this first test. The site was again inspected six months later again with very good results. Vegetation had become well established and the combination of blanket materials appeared to be doing the trick.
