South Lake at Stonebrook – An Innovative Solution to Golf Course Erosion Control

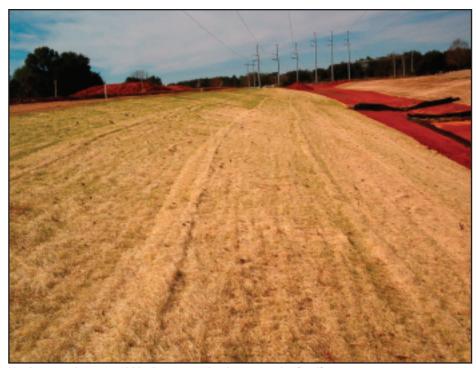
Net-less erosion control blanket protecting long stretch of golf course.

Baynes decided to try the innovative product on the sandy clay soils of the golf course. Approximately 200 rolls of the net-less ECB were installed on the course to prevent soil erosion and enhance vegetation establishment without the headaches of ECB netting. The product was used on hillslopes up to 3H:1V, holding ponds, and stormwater retention areas.

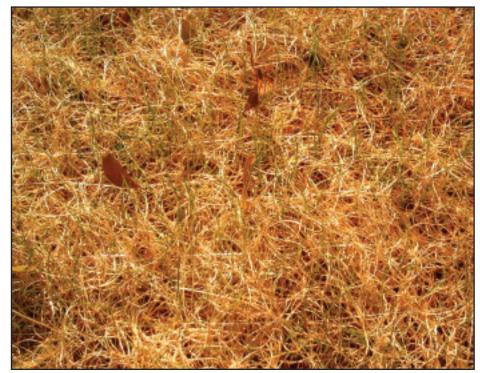
Winter Rye emerging through erosion control blanket shortly after seeding.
