## Introduction

There's something about cold, bubbling trout water that can relax almost anyone (see Figure 1). Thus, it is imperative to conserve and restore our precious streams and rivers for future generations to experience and enjoy. With this in mind, the Lakeshore Chapter of Wisconsin Trout Unlimited (LSTU) undertook a project starting in 2019 to repair and enhance existing river restoration improvements and expand improved water into a new section of the Onion River outside of Plymouth, which is located in East Central Wisconsin. The environmentally sensitive site is in a floodplain and wetland forest surrounding a trout stream on State of Wisconsin Department of Natural Resources (WDNR) managed lands.

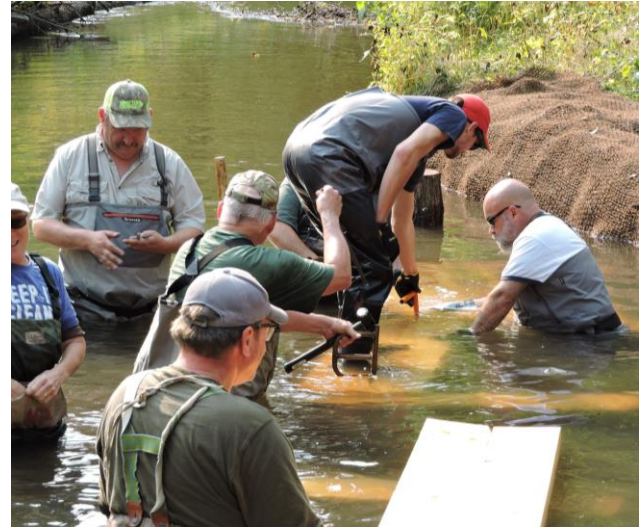
Figure 3: Project staff and volunteers constructing lunger structure.

Construction of the new lunger structures (see Figures 3, 4, and 5) started with the banks being properly shaped with equipment. Next, the newly shaped banks were wrapped in an open weave coir material. Repurposed posts, which were made from black locust trees, were donated from a local YMCA camp. They were pounded into the stream bottom to form the main anchoring support for the lunger structure. Boards of lumber were then fixed to the posts to build the structure itself. Rip rap was placed along the top face of the finished structure, then the final backfilled soil was seeded and covered.

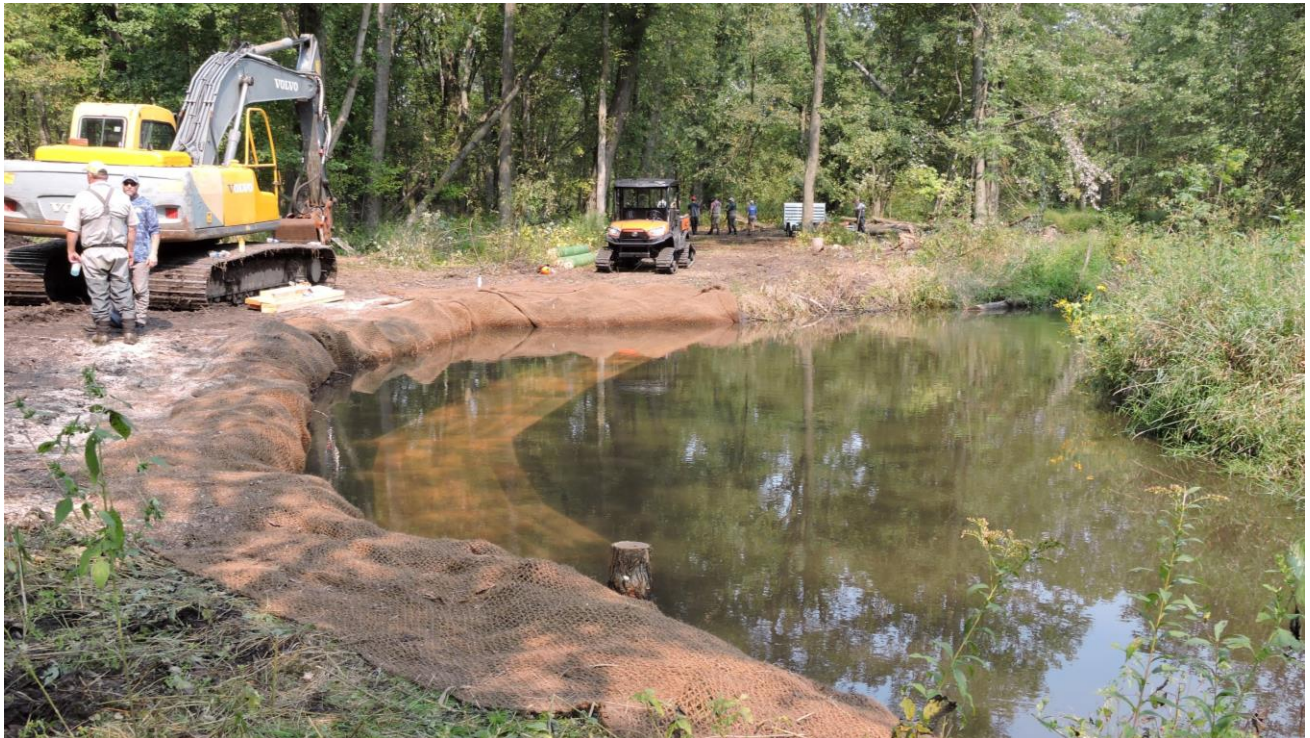
Figure 4: Completion of lunger structure before final backfilling, seeding, and covering. Note black locust post near center of photo that had not been cut off yet.

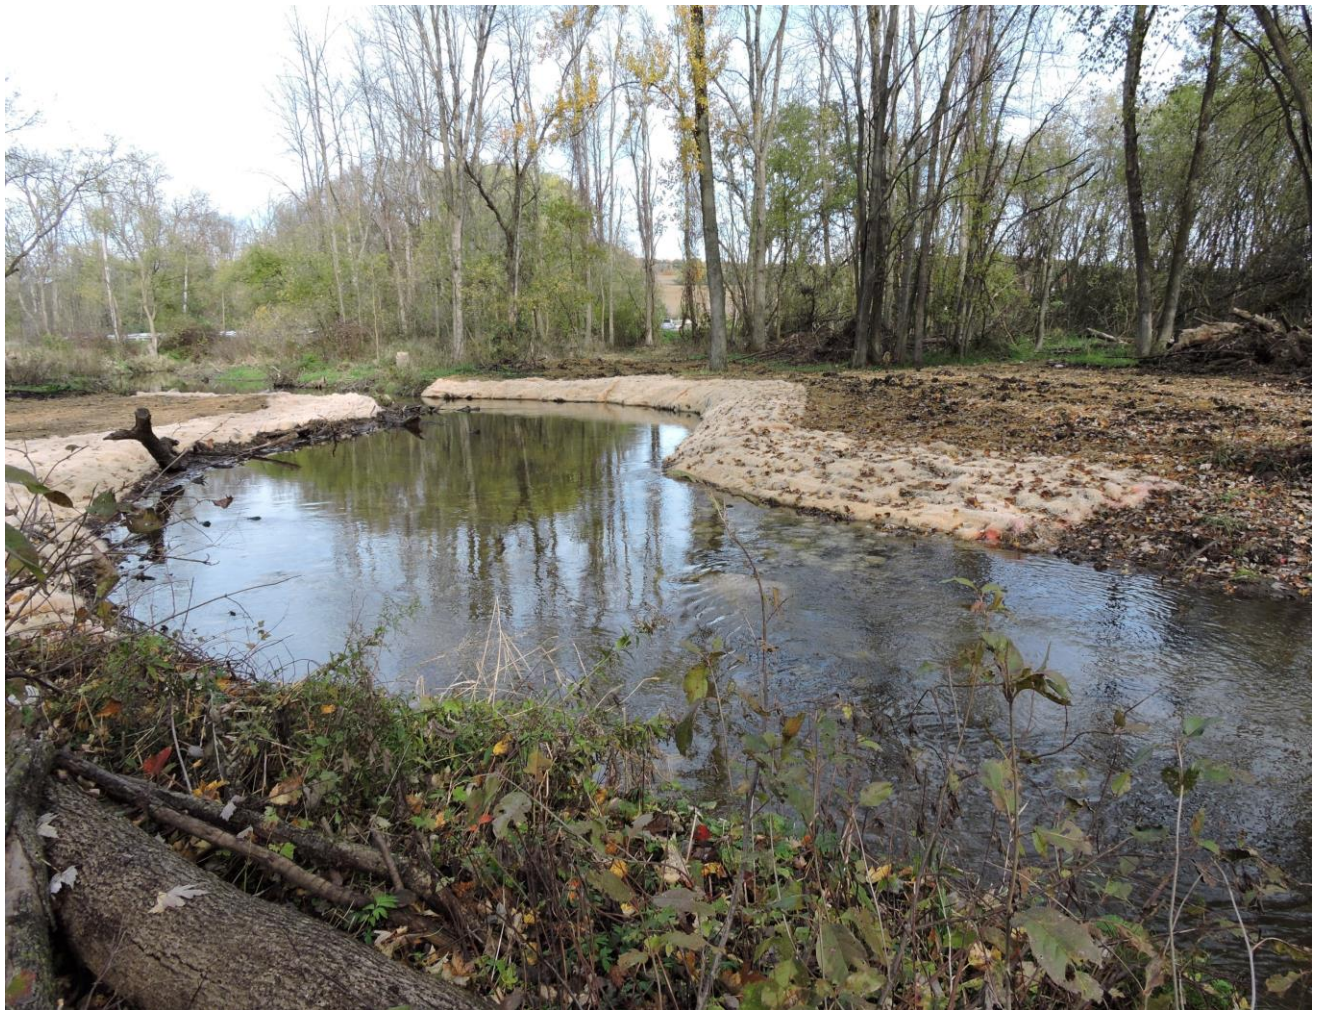
*Figure 5: Completed lunger structure from Figure 4 protected with Curlex NetFree erosion control blanket.*

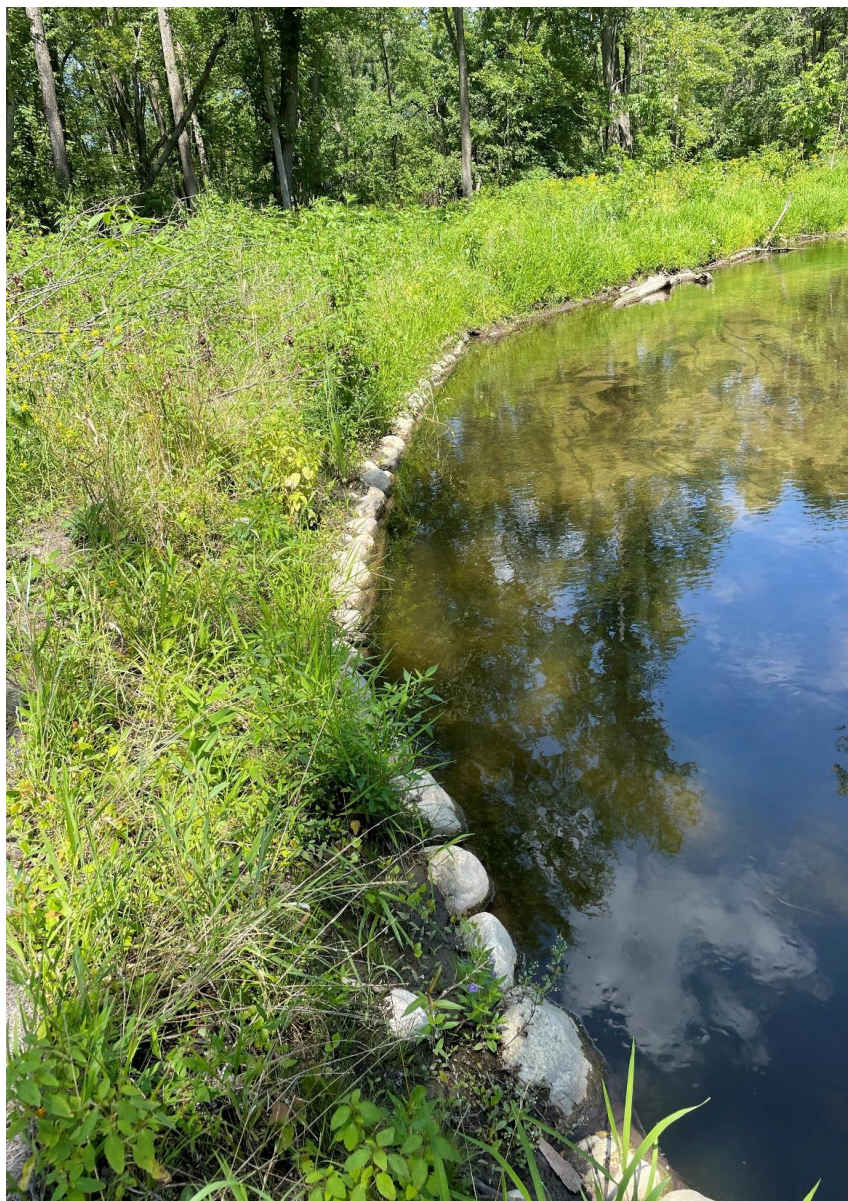
*Figure 6: Vegetation on lunker structure under bank from Figures 4 & 5 that was protected with Curlex NetFree erosion control blanket approximately one season after installation.*

Curlex® NetFree™ erosion control blanket (ECB), manufactured by American Excelsior Company, was chosen for protecting the environmentally sensitive banks of the trout stream after the improvements were made (see Figure 6).

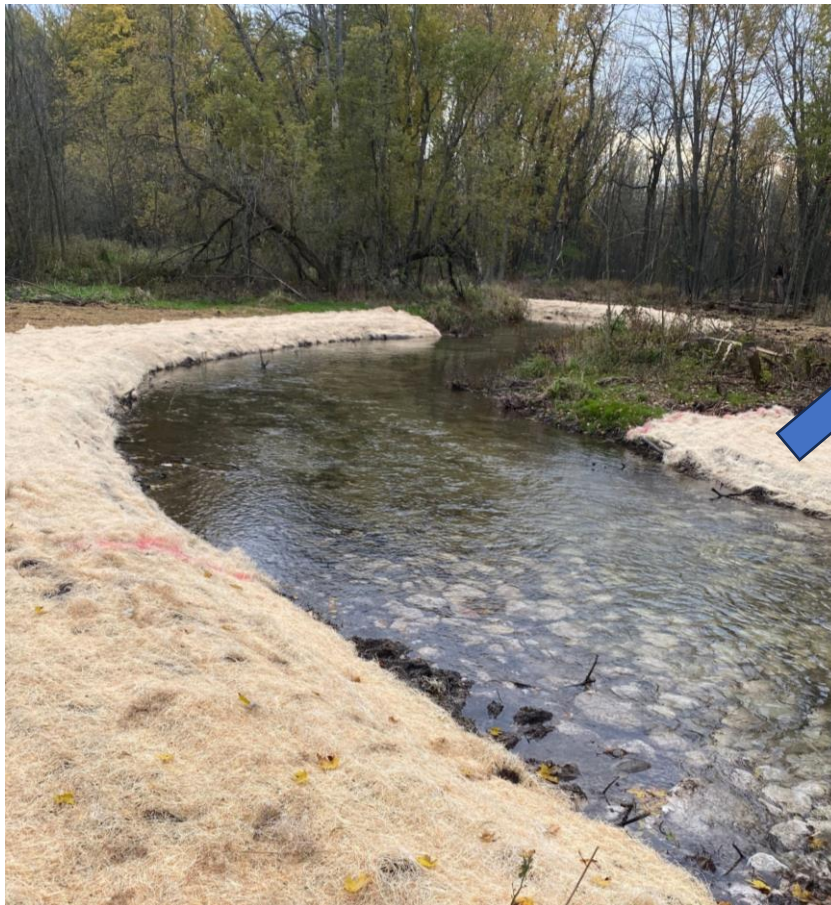
*Figure 7: Curlex NetFree, a naturally seed-free erosion control blanket, protecting the precious trout stream after rip rap was added to improve flow conditions and before native seed mix germinated.*

In general, hydromulches containing toxic malachite green tracer dyes and/or other potential chemicals of concern are commonly avoided on wildlife friendly and environmentally friendly projects because of their tendency to slump (i.e., fail) and their dependency on additives and chemicals. Curlex NetFree (see Figures 7, 8, and 9) is a completely biodegradable, chemical-free covering designed to hold the seed bed in place until vegetation becomes established. This project applied a native seed mix designed specifically for detention basins at a rate of 10 lb/ac (11.2 kg/ha), with ReGreen cover crop added. Overall, the native seed mix contained 46.37% wildflowers and 53.63% grasses, sedges, and rushes. Please contact the author for exact details on the seed mix, if interested. Curlex NetFree was secured to the soil using biodegradable E-Staple®, by American Excelsior Company.

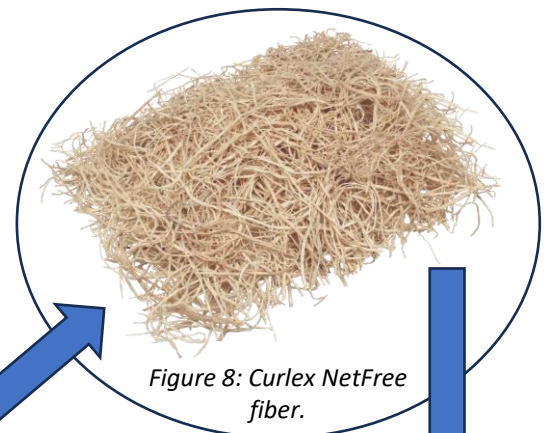
*Figure 8: Curlex NetFree fiber.*

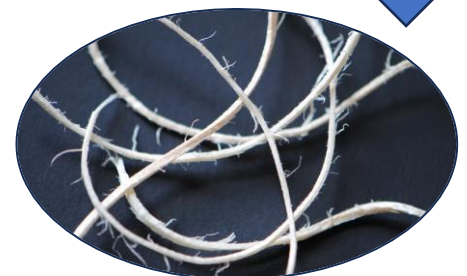
*Figure 9: Close-up of curls and barbs on interlocked Curlex fibers.*

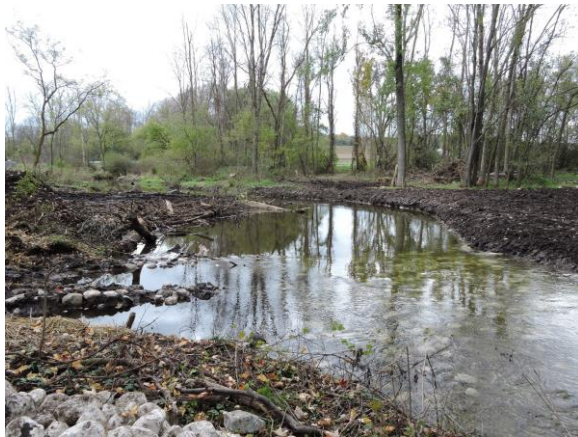
*Figure 10: "Before" photo of restored bank section before covering was installed.*

The project team was able to take on a significant amount of work, with the help of WIDNR, that allowed them to complete over 900 ft (274.3 m) of restoration work on the Onion River in Sheboygan County (see Figure 10). Additional work included the repairs of several existing lunger structures in the project area. Lastly, the team repaired large sections of bank all along the river (see Figure 11). The completed work will have lasting impacts, which will provide improved fish habitat and angling opportunities for the public. Visual observations documented immediate changes to local populations of trout who took residence in the new section of repaired stream. The years of planning and hard work are thankfully showing positive returns already (see Figure 12). The improvements and structures all seem to be holding up as designed, and the site has revegetated nicely.

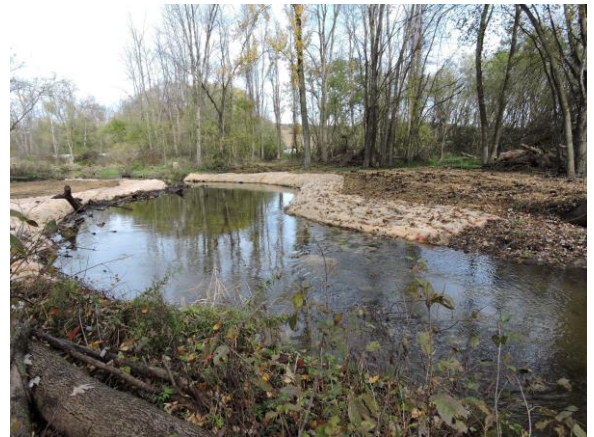
*Figure 11: "During" photo of Curlex NetFree protecting restored bank section shown in Figure 10 shortly after installation.*

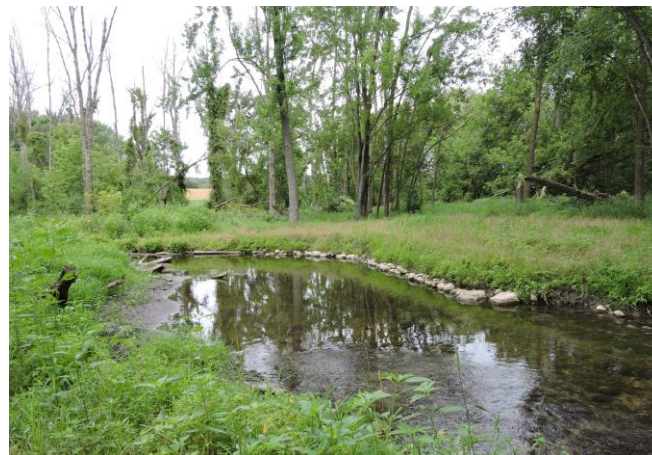
*Figure 12: "After" photo showing vegetation through the Curlex NetFree protected restored bank section as shown in Figures 10 & 11.*
