Introduction

The Town of Big Flats, New York had a challenging series of stormwater channels on a public right-of-way. The series of stormwater channels transported rainwater and snowmelt that originated from a steep hill, crossed right of ways, and eventually emptied into a stream. The long downhill run caused concentrated flows in the channels that temporary rolled erosion control products (RECPs) could not withstand.

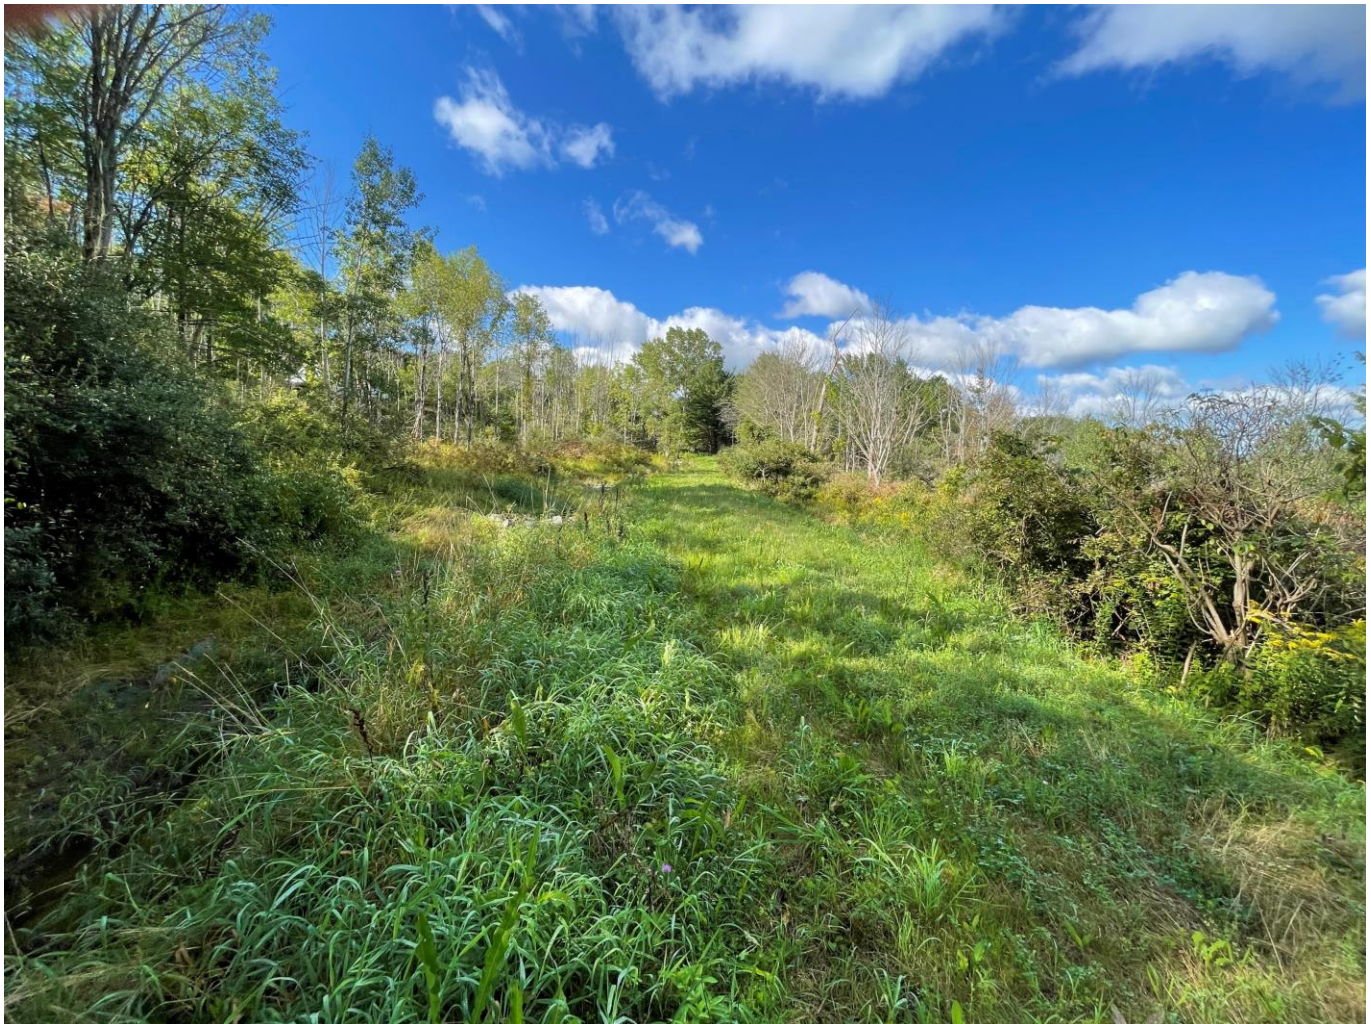
Figure 1. Vegetated Stormwater Channel Reinforced by TriNet® Recyclex® TRM

The decision was made to protect the land from erosion and scour by investing in a comprehensive overhaul of the failing stormwater channel system (see Figure 1).

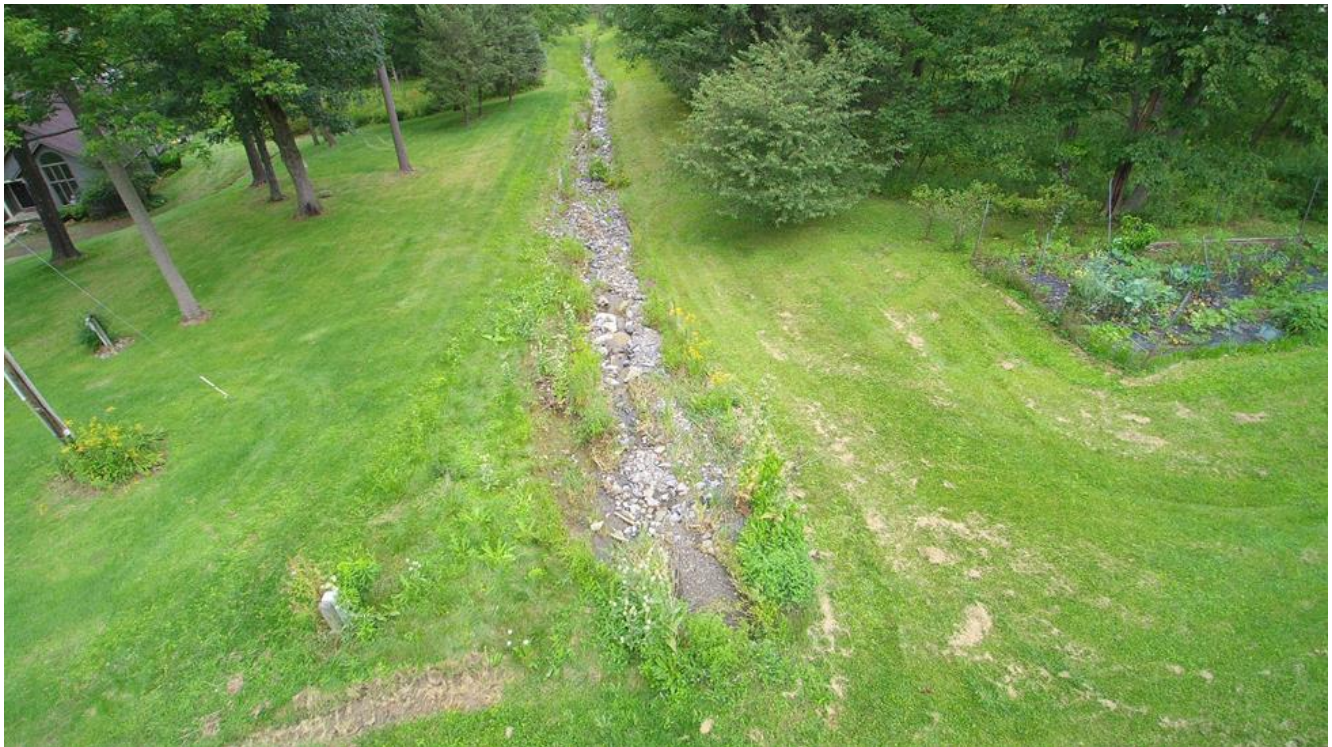
No modern Best Management Practices (BMPs) were used in the original channel design, so property damage and maintenance problems occurred with each large rainfall and snowmelt event. Extensive soil erosion in the channels was an eyesore, and during large rain events, the stormwater volume exceeded the containment capacity of the existing channels.

To complicate matters, upstream channels that crossed private property were altered for aesthetic purposes over the years. These alterations significantly reduced the system's ability to slow the water velocity entering the lower channels. The existing stormwater channels were lined with rip rap and had eroded swales approximately 4' wide and 24" deep (see Figure 2).

Figure 2. Outdated and Eroded Stormwater Channel

A successful stormwater control plan using modern BMPs was needed to reduce the chance of damage to nearby properties.

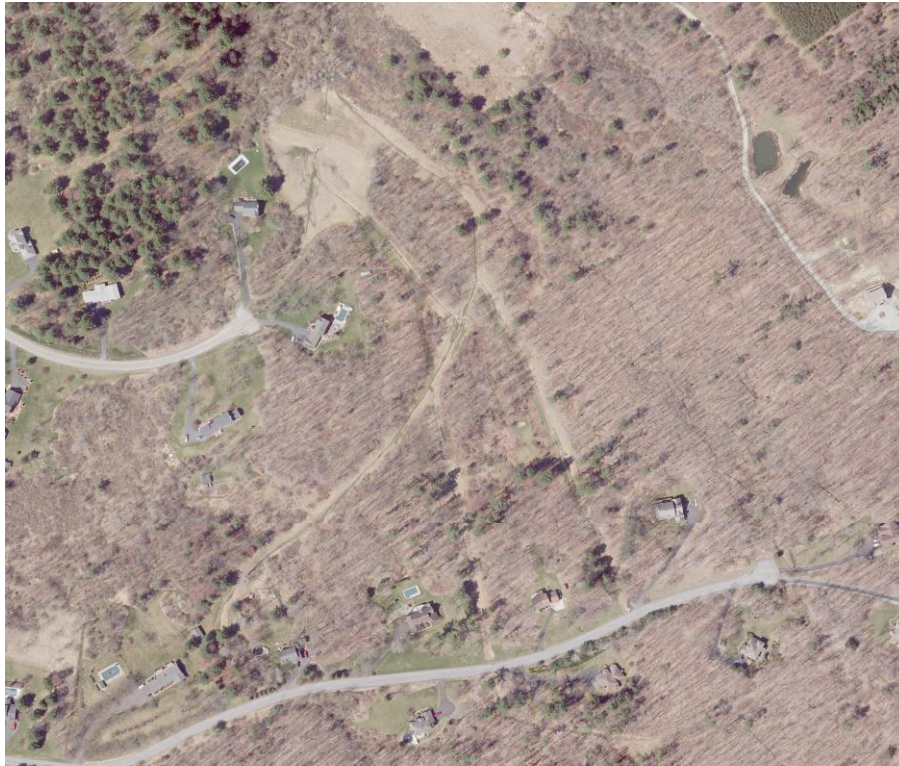
Figure 3. Aerial View of the Project Site

After final engineering and design solutions were approved for the site (see Figure 3), Wenzel Contracting began the erosion and sediment control improvements. The erosion control products were supplied by Chemung Supply Corporation. Many of the required erosion control solutions were manufactured by American Excelsior Company.

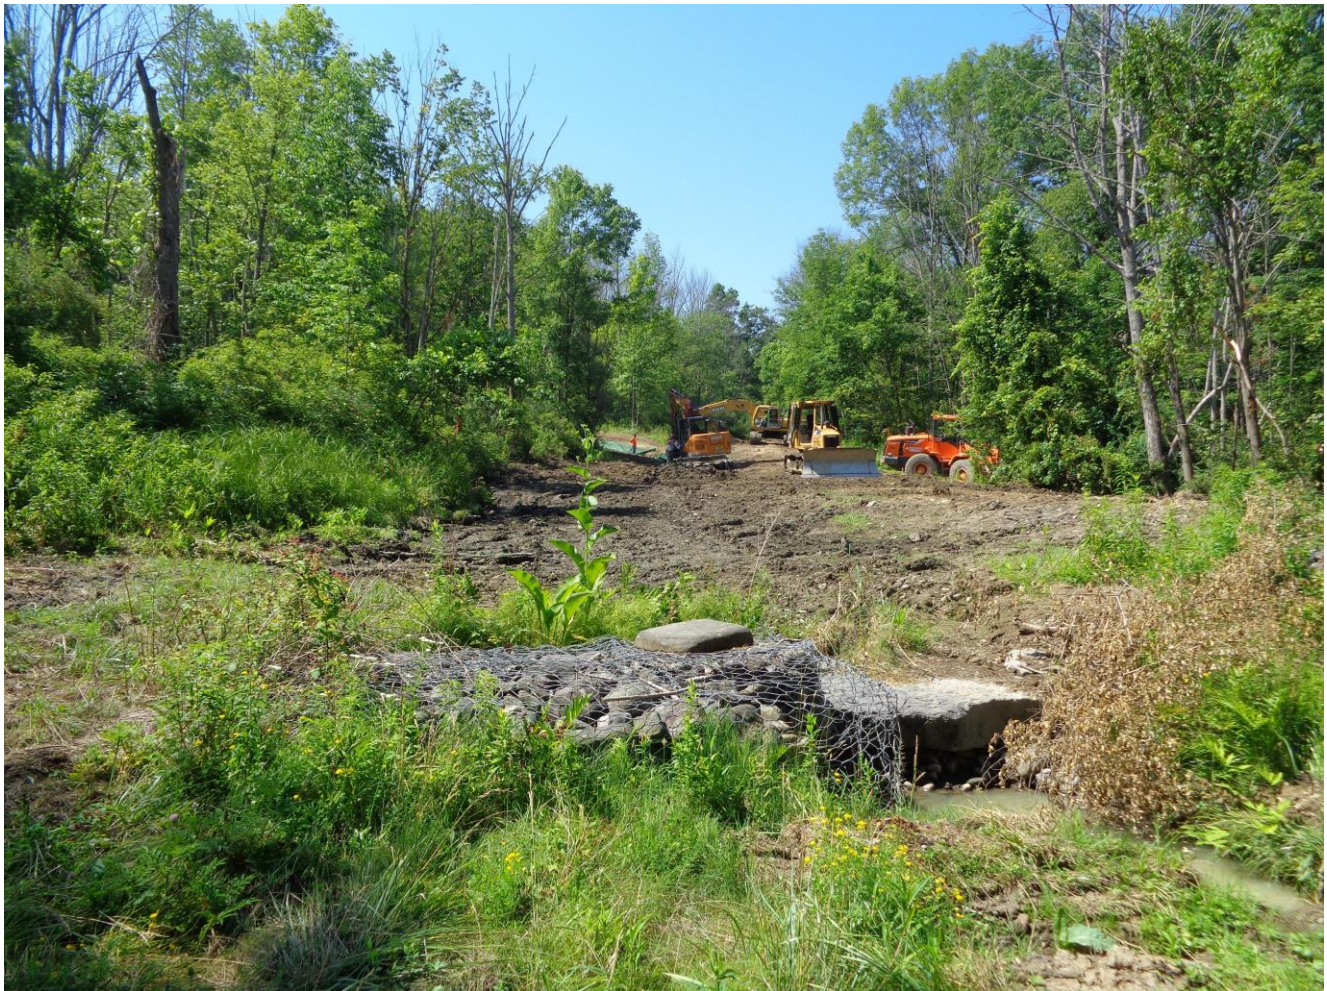
Figure 5. Removal of Existing Rock and Channel Reshaping

Existing channels were excavated, and the existing rock channel bottom was removed. The channels were then reshaped, deepened, and widened to create more stormwater capacity and stormwater infiltration (see Figure 5). After excavation was completed, the channels were compacted and fine graded to remove any rills. The contractor also made sure that the channel was free of obstructions such as tree roots, large rocks, and other foreign objects. Topsoil was evenly distributed at a depth of 4" to prepare for seeding then the TRMs and ECBs were installed.

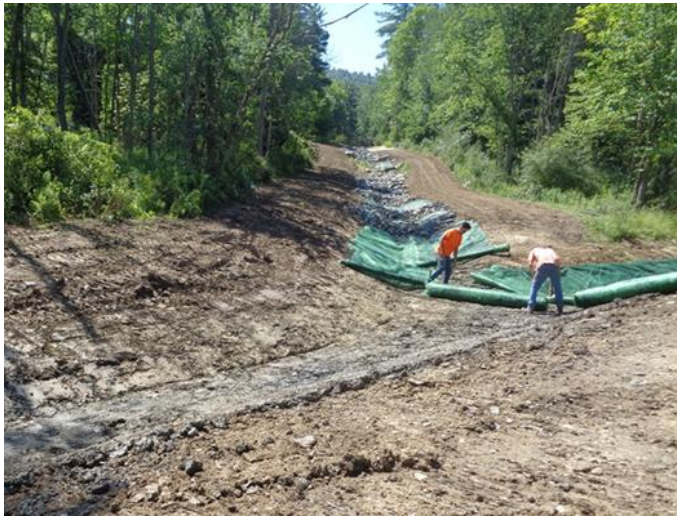
Figure 6. Installation of TriNet Recyclex

After the channels were repaired and reshaped, they were seeded and fertilized. A cover crop of grain rye was applied at 20 lb/ac and the specified upland low-growing wildflower and grass mix was applied at 30 lb/ac. After the seeding was completed, the swales were lined with TriNet Recyclex and new rock check dams were installed on top of the TRM. Side slopes were covered with AEC Premier Straw ECBs (see Figures 6-9).

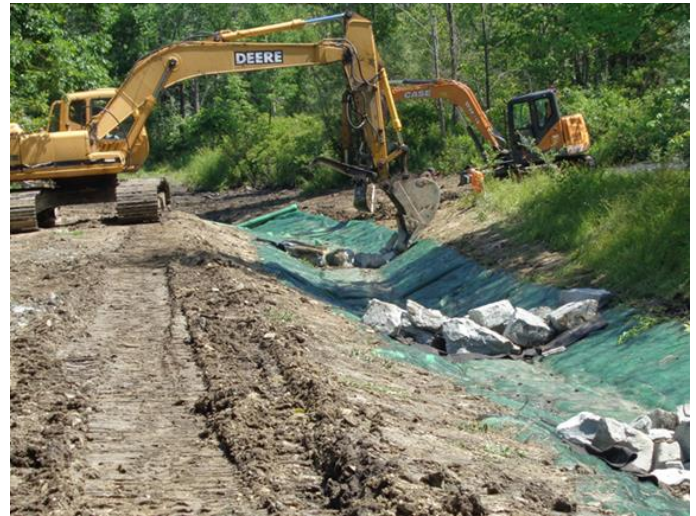
Figure 7. New Rock Check Dams Over TriNet Recyclex

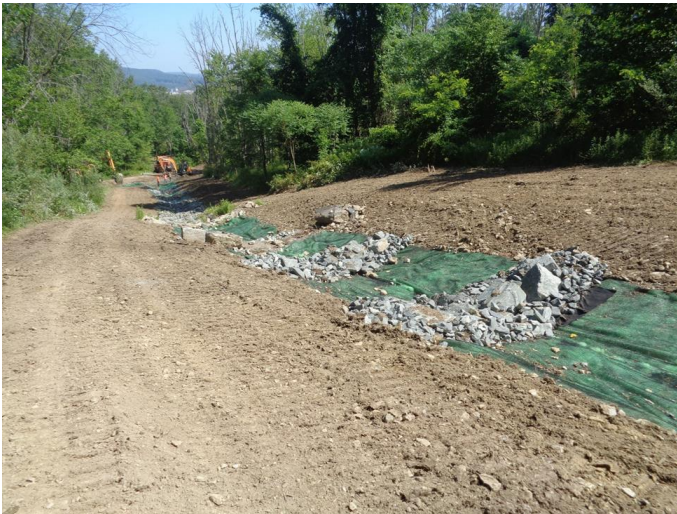
Figure 8. TriNet Recyclex and New Rock Check Dams

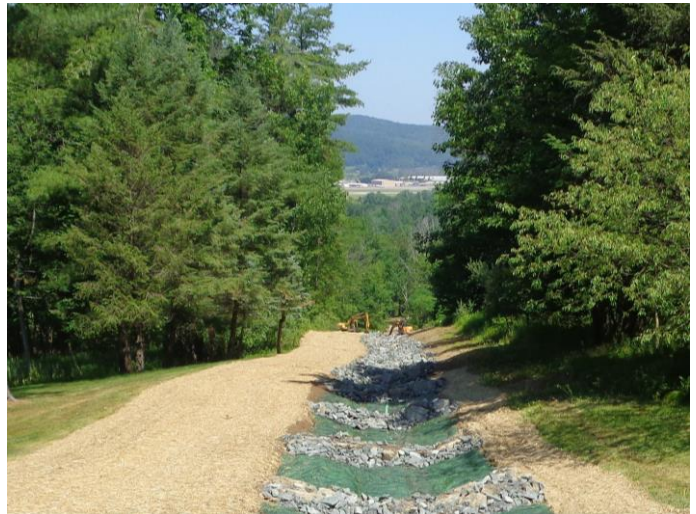
Figure 9. AEC Premier Straw Installed Outside Channel

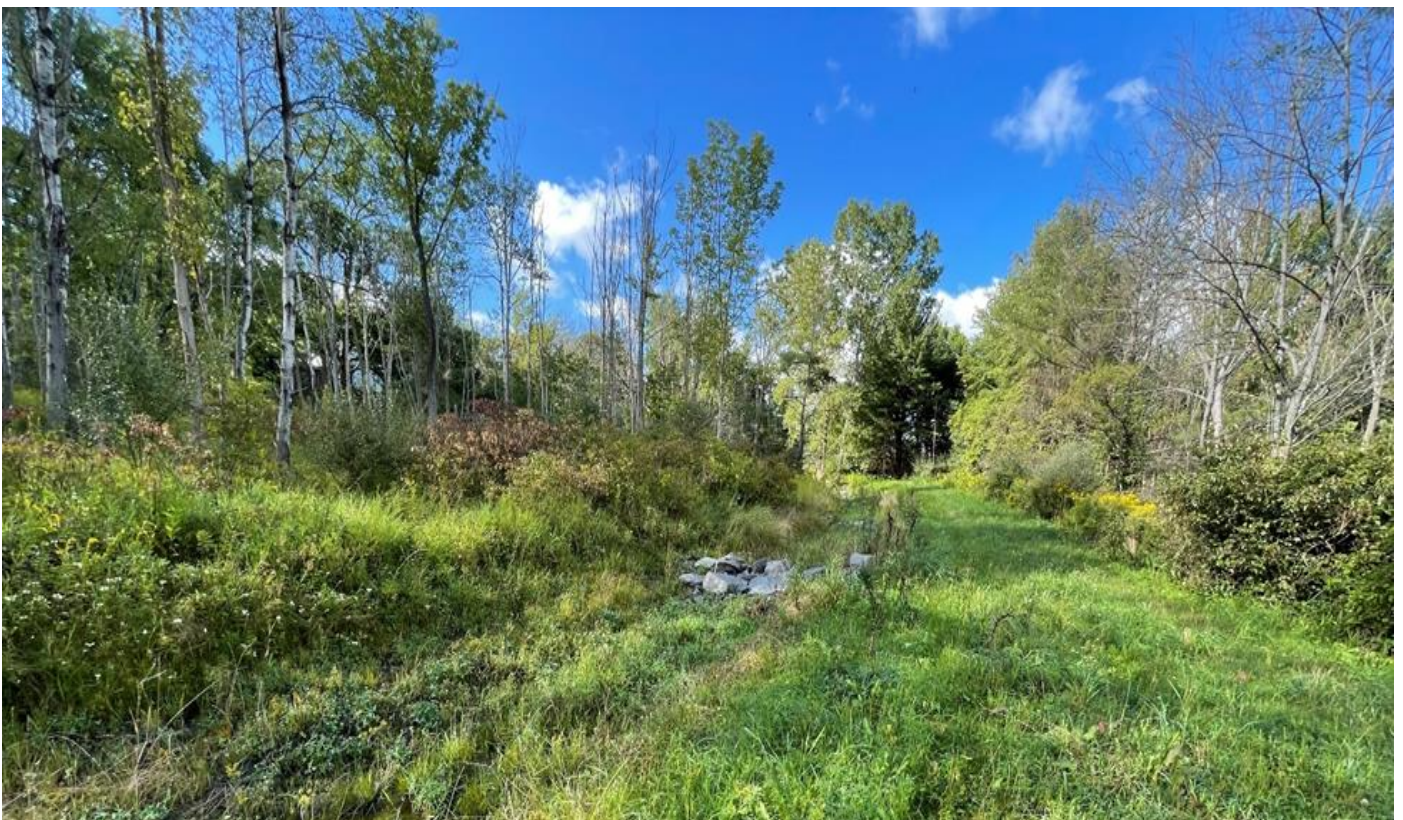
Figure 10. Completed Vegetated Swale Reinforced by TriNet Recyclex TRM

The design team understood the shear stress capability of vegetation alone would not survive the design flows of the channel. TriNet Recyclex TRMs successfully protected the channels and reinforced the vegetation, allowing it to withstand high stress events and to carry runoff from the site. Paired with rock check dams, the BMPs protected the site and surrounding area.

In total, more than 6,500 yd² of TriNet Recyclex TRMs and 3,000 yd² AEC Premier Straw ECBs were used on the complex, ecologically sensitive two-mile long project (see Figure 10).
