Introduction

A 60-acre (24-hectare) project involving utility upgrades, road resurfacing, and sidewalk installation began in early spring in an area of Wisconsin that experienced sporadic precipitation events. Therefore, the appropriate selection and placement of erosion control Best Management Practices (BMPs) was paramount to both the visual appeal and overall success of the project (see Figure 1).

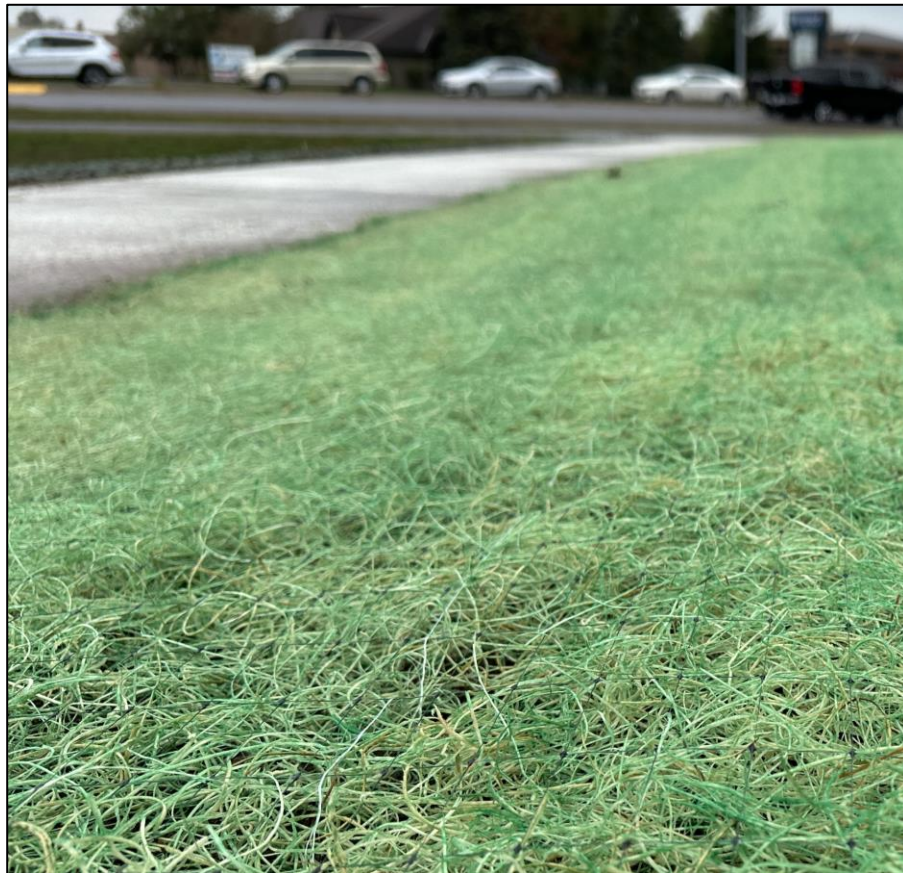
Figure 1. An erosion control blanket (ECB), Curlex® II QuickGRASS®, installed on a newly constructed section of the project area.

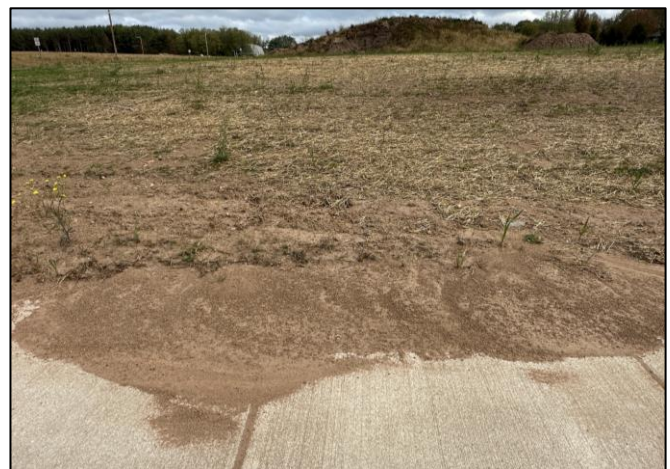
The blown straw installations failed to protect the areas on which they were applied and created more problems than they solved (see Figure 2).

Straw fibers lay flat and form bridges over irregularities in the soil. They are hollow and float during hydraulic events. When exposed to sheet flow, the blown straw fibers' characteristics can lead to erosion and partial or complete loss of the seed bed. In this case, sediment was deposited directly onto the sidewalk, which was an eyesore, and its cleanup was an unplanned expense.

Figure 2. Failed blown straw installation that led to sediment being deposited onto the sidewalk.

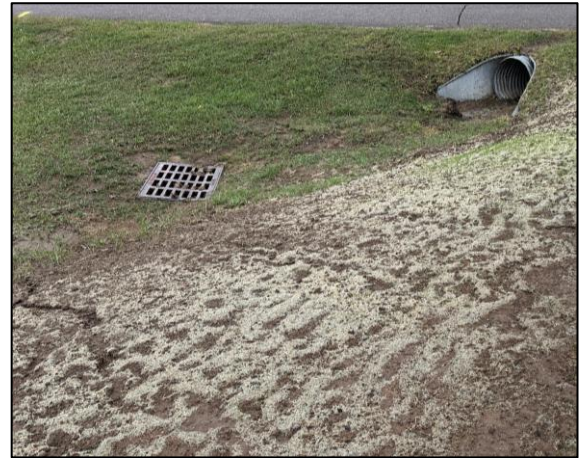
The hydraulic mulch was not applied to the curbside areas until mid/late September. Within several days of its initial application, the site experienced two rainfall events. These events led to a partial washout of the hydraulic mulch material (see Figure 3). The washed-out areas saw rills, uneven vegetative growth, and instances of severe erosion (see Figure 4). Some of the eroded sediment washed into the street and reached nearby stormwater drains before site personnel were able to clean up the area. Expenses due to cleanup, buying new BMPs to replace the failed hydraulic mulch, and the re-installation of the new BMPs were all additional unplanned costs to the project.

Figure 3. Partial washout of a hydraulic mulch application near a stormwater drain.

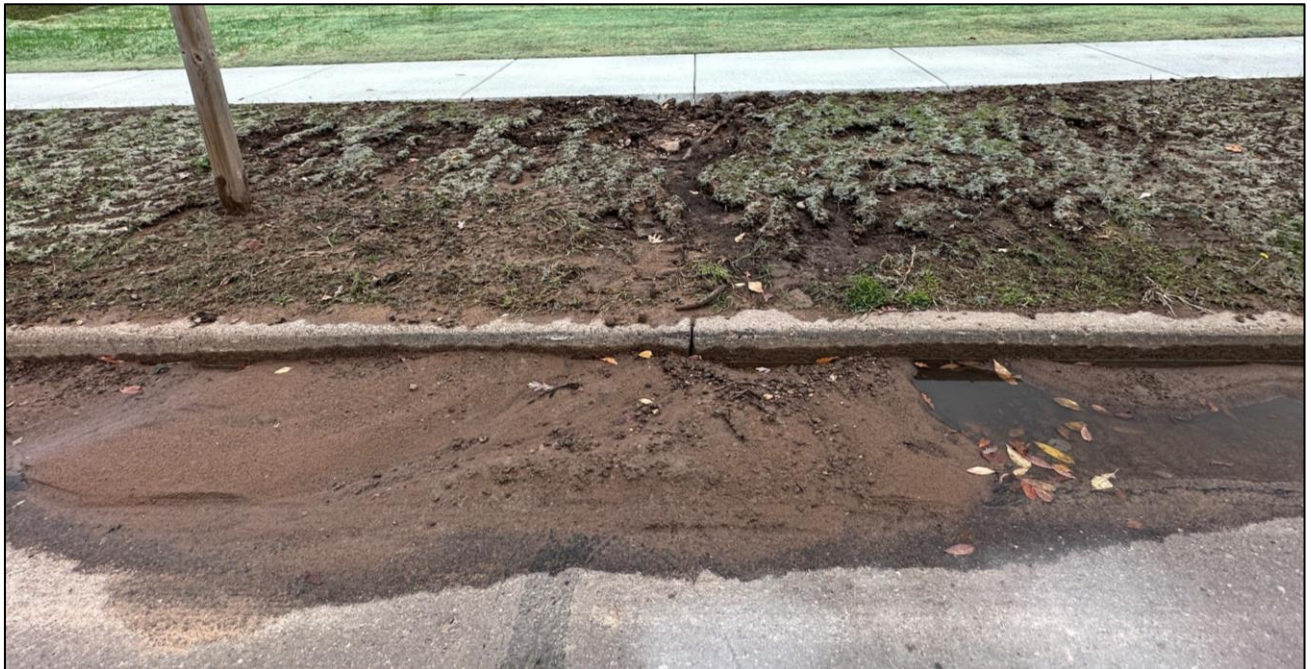
Figure 4. Severe failure of a hydraulic mulch application.

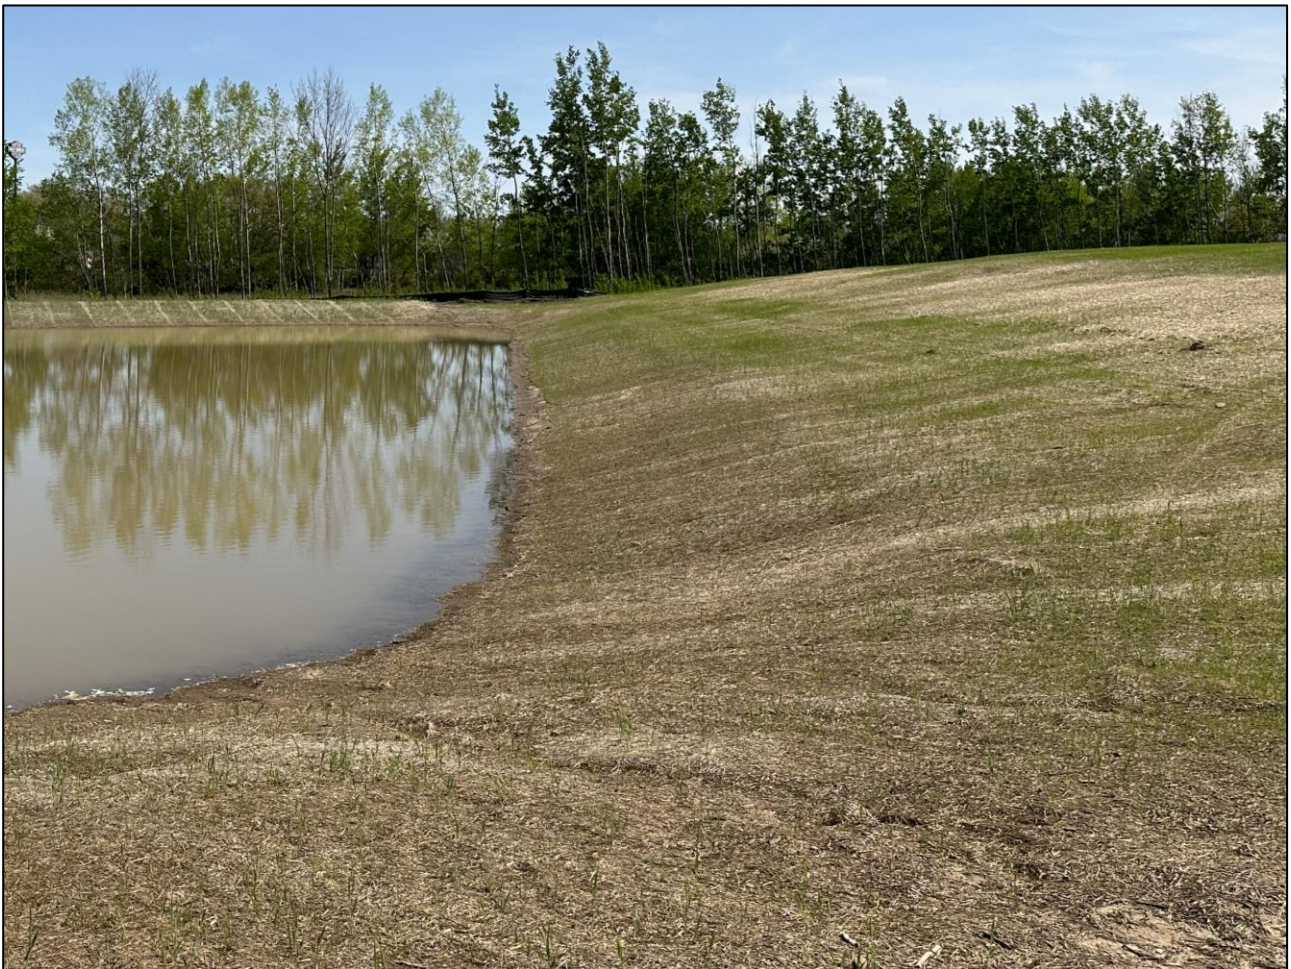
Straw ECBs did offer more erosion protection than the blown straw and hydraulic mulch installations. However, the straw ECBs did not fully protect the slopes from soil loss and seed migration during the precipitation events (see Figure 5). Some of the straw blankets had to be replaced by higher-performing ECBs, which added to the list of unplanned project expenses.

Depending on its Manning's n value, an ECB's fiber type can either have an increasing or decreasing effect on the energy of sheet flow. Manning's n is a measure of a product's hydraulic roughness, and a higher Manning's n helps decrease energy, slow water flow, increase water infiltration, and keep the underlying seed and soil in place. Straw fibers have a lower Manning's n than other ECB fibers, such as aspen excelsior.

Figure 5. Evidence of seed migration from a straw ECB installation surrounding an on-site sediment retention pond.

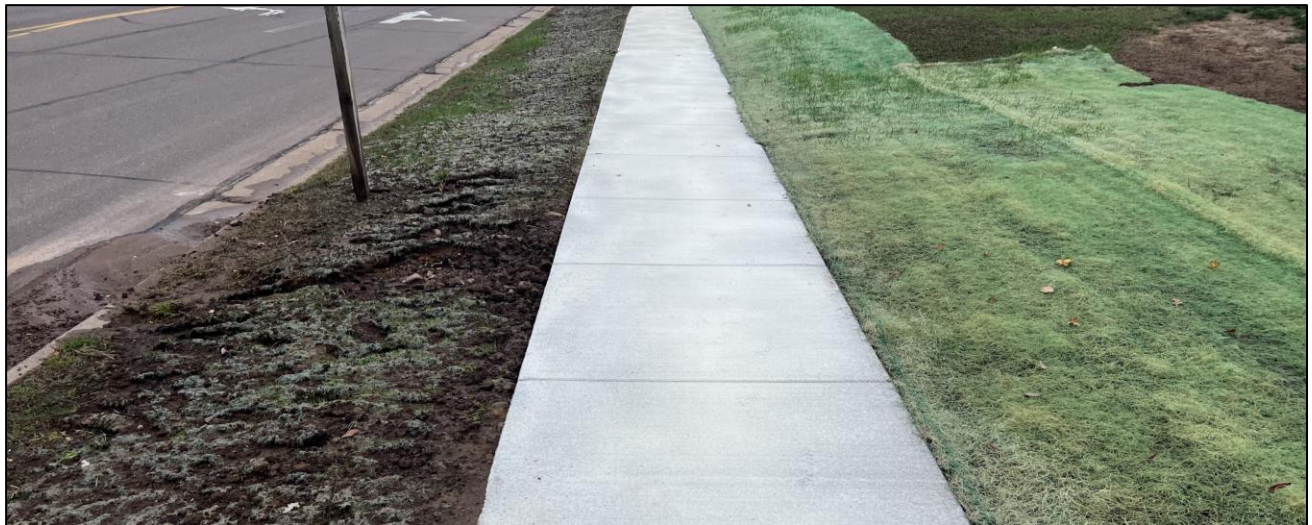
In contrast to the other BMPs, even when installed on steeper slopes, the Curlex ECBs saw minimal soil erosion and seed migration after the same precipitation events that the other BMPs were exposed to (see Figure 6). Just imagine how much money could have been saved if the Curlex ECBs would have been installed across the site. Material and installation costs would only have been incurred once, cleanup costs would have been virtually eliminated, and the stormwater drains, nearby wetlands, and impaired river would not have been exposed to the level of contamination they received from the failures of the other BMPs that were chosen based on material cost and not project cost.

Engineered Curlex fibers are made from Great Lakes aspen trees. Curlex expands and contracts with moisture, allowing the curled and barbed fibers to form a “Velcro-like” connection that conforms to irregularities in the soil. Curlex fibers also have a high Manning’s n value that helps dissipate energy from hydraulic forces (such as sheet flow) for increased water infiltration and enhanced soil and seed bed protection during hydraulic events.

Figure 6. Curlex II QuickGRASS installed opposite the hydraulic mulch installation shown in Figure 4.

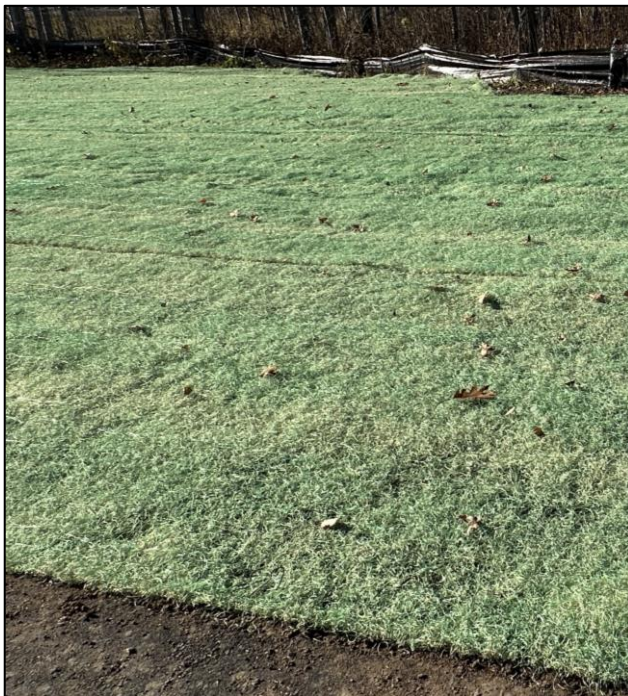
Figure 7. Curlex II QuickGRASS installation.

Curlex® II QuickGRASS® (see Figure 7) was used on most of the flatter and shallow-sloping curbside and inland areas following the failures of the other BMPs. Curlex fibers' ability to create a "greenhouse effect" when exposed to moisture fosters favorable seed germination and establishment conditions. Curlex® II FibreNet™ was installed on many of the roadside slopes near the sediment retention ponds and wetlands (see Figure 8). It provides all the features and benefits of other Curlex products while encasing the Curlex fiber matrix between two layers of 100% biodegradable jute netting with non-welded slip joints.
