## Introduction

A family farm owner in Wisconsin had concerns over potential sediment discharge from a pasture road (see Figure 1) into a nearby Class II trout stream that lay adjacent to their property (see Figure 2). Located on a moderate slope, the pasture road's vegetation had recently been destroyed due to multiple trees being removed. This resulted in large areas of exposed bare soil. The site was both an eyesore and, if not addressed quickly, would create long-term erosion and hillslope stability issues for the farm owner. They also wanted to protect the precious water resources and the wildlife that lived in and around them from sediment and nutrient pollution.

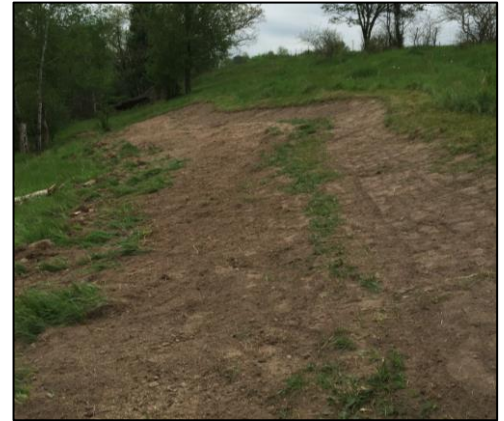
*Figure 1: Ground-level view of the pasture road.*

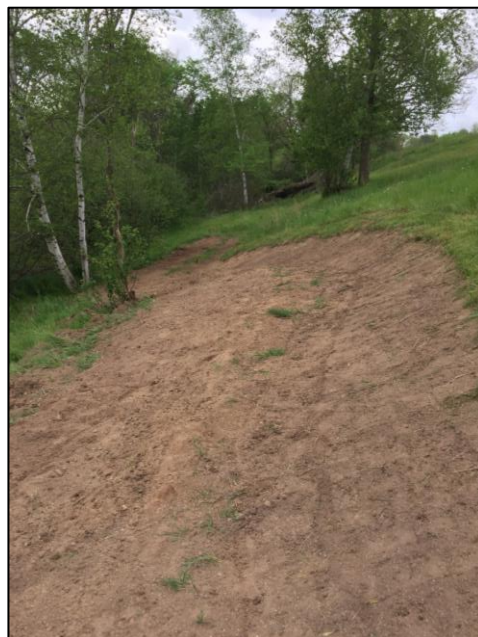
*Figure 3: The exposed area after clearing, raking, compacting, and seeding.*

The exposed area (see Figure 3) was located on a roughly 4H:1V slope that contained rocks and residual root systems of previous farmland grasses, making grading difficult. Such conditions required the use of a Best Management Practice (BMP) that would provide immediate onsite erosion control, protect the underlying seed bed during hydrologic events generating run-on from above, and give vegetation a prime growth environment upon germination.

The use of large grading equipment was not an option due to site access constraints. Therefore, after clearing the site of large rocks and roots, the exposed sandy loam soil surface was hand-raked and compacted before being seeded with a grass mix and fertilized.

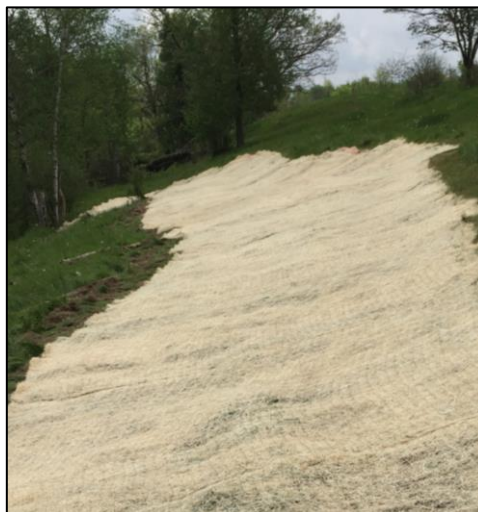
*Figure 4: Completed installation of Curlex® II on the disturbed slope.*

The Curlex II was rolled out vertically on the slope and cut into approximately 10 ft (3.0 m) lengthwise sections that were abutted against each other across the slope (see Figure 4). The sections were then anchored to the subgrade using traditional 6.0" (2.5 mm) sod staples according to American Excelsior Company's recommended staple pattern guidelines for installing Curlex ECBs on slopes less than or equal to 4H:1V.

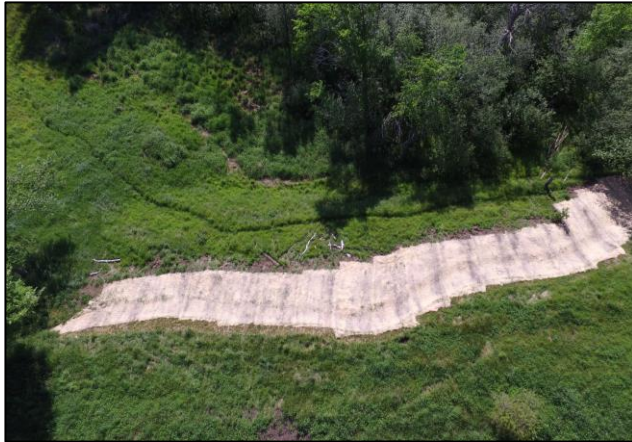
*Figure 5: Aerial view of completed Curlex II spring installation.*

The Curlex II installation was completed in spring (see Figure 5). Project personnel returned to the site a month later (see Figure 6) to find it completely vegetated with no known runoff issues. The pasture road on the exposed hillslope area was now stabilized, and the farm owner was satisfied with the knowledge that the trout stream would be protected from sediment and nutrient pollution.

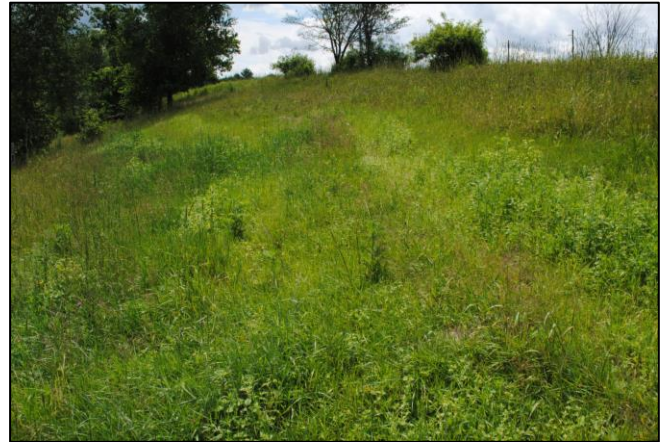
*Figure 6: Completed Curlex II installation one month after installation.*

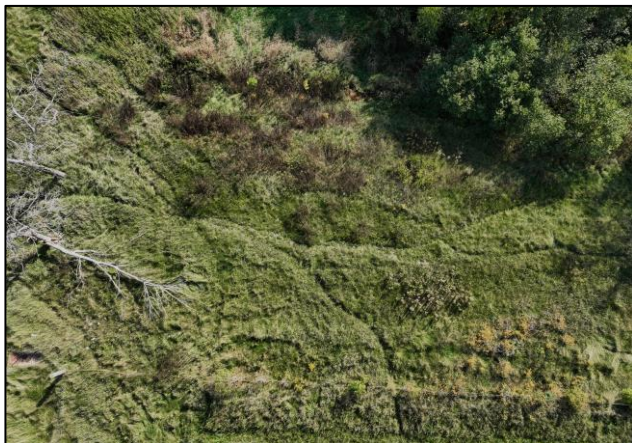
*Figure 7: Aerial view of completed Curlex II site a few years after installation.*

The site was re-visited a few year later to examine the impact and aesthetics of the installation (see Figures 7 and 8). The site showed no signs of instability; without prior knowledge of the project area, it was difficult to guess where an ECB installation had taken place.

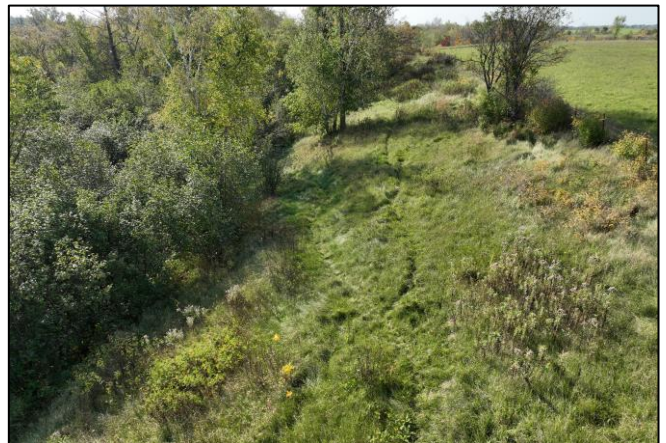
*Figure 8: Tree-level view of completed Curlex II site a few years after installation.*
