Case Study – Curlex Bloc Wetland Mitigation Bank

I. Introduction

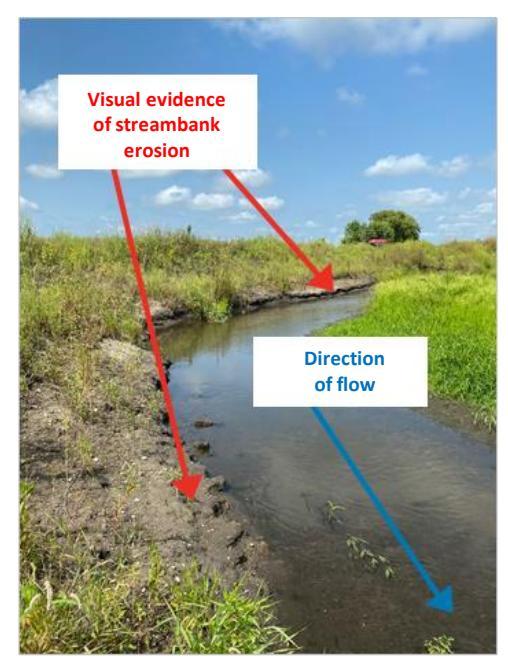
Figure 1 provides the basis for the case study. This is a view of a stream that is in the early stages of down- cutting and it is beginning to erode the outside bend in the stream. These reallife stream conditions continue to be exacerbated by changing climate conditions. Across the country we continue to see more frequent intense storms occurring with short recurrence periods. These storms typically discharge large volumes of precipitation in shorter periods of time. This then causes large run-off volumes to be conveyed through stream segments that are already in need of restoration. Further adding to the run-off discharge volumes is the continued development within the watersheds, that increase the impervious areas, which then changes the time it takes the peak flows from entering the steams. These peak flows reach the stream faster than they had in the past. This, coupled with the increased storm frequency and intensity, contributes negatively to the continued stability of the stream.

Figure 1: Existing stream bank conditions at project site.

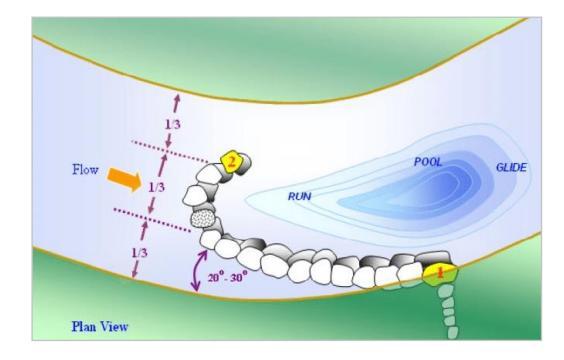
Figure 2: "J" Hook image courtesy of US Fish and Wildlife Service.

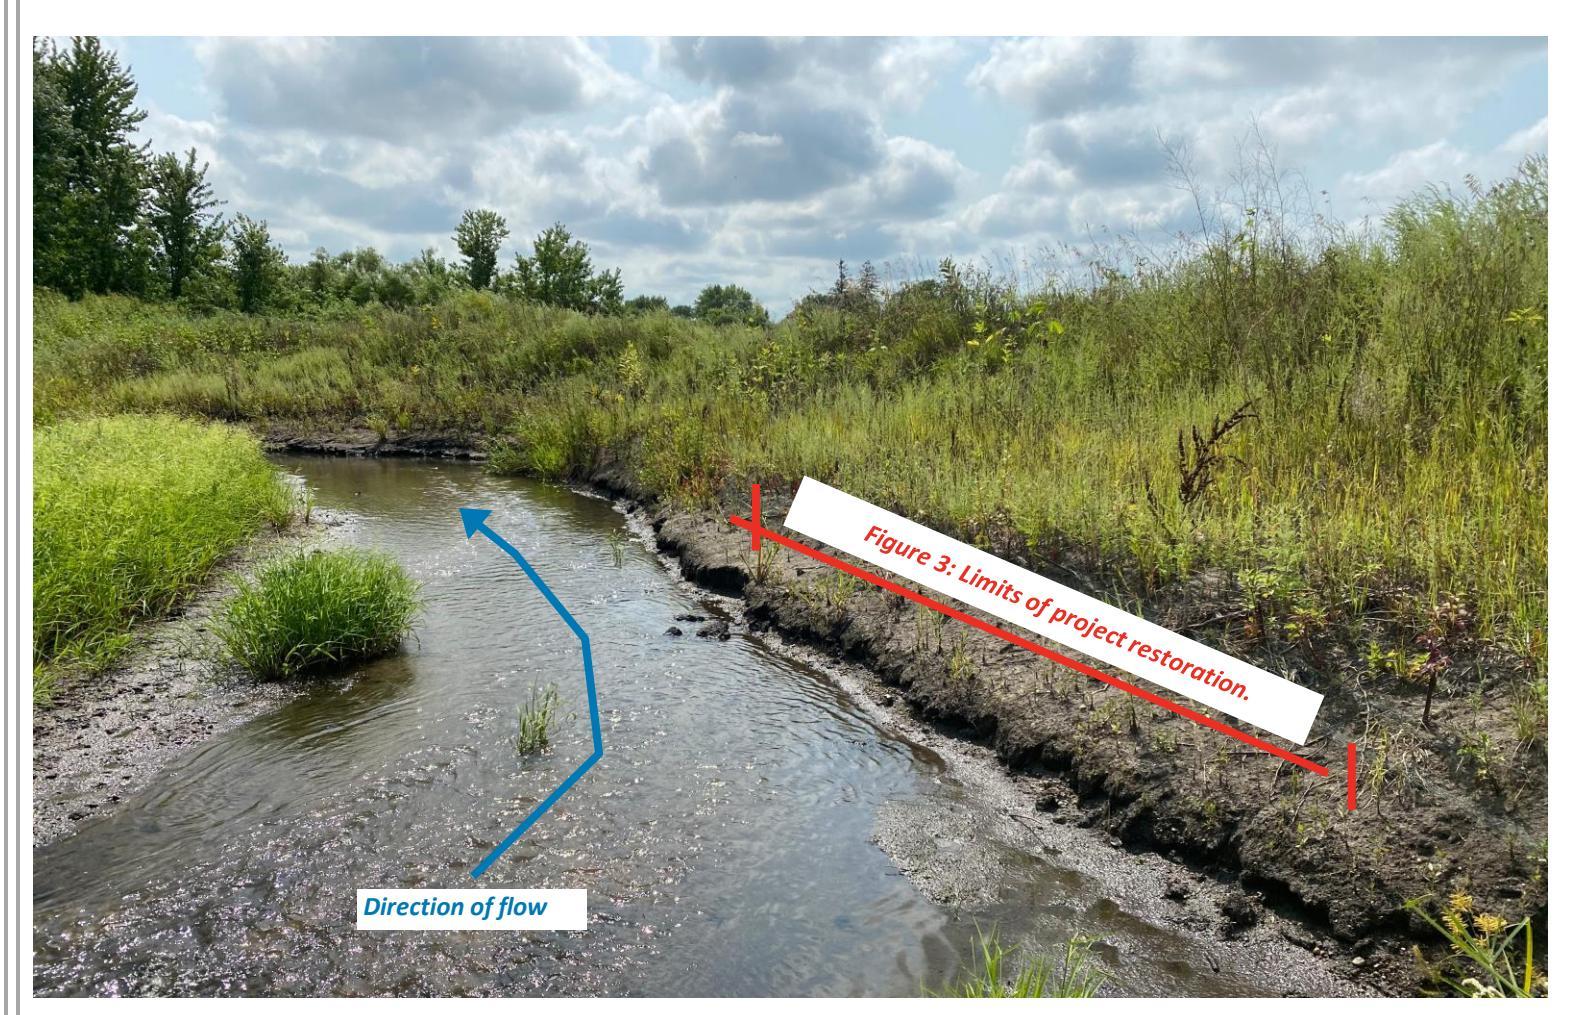
Figure 3: Limits of project resources

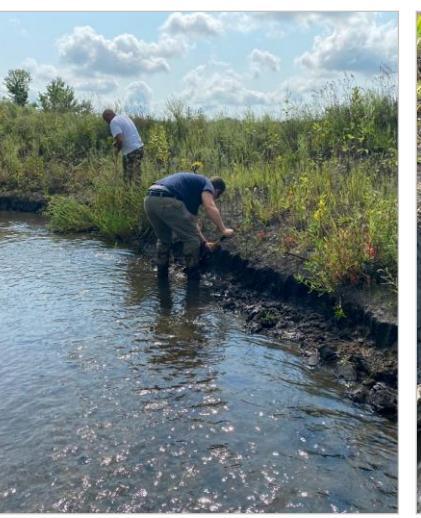
This step required preparing the restoration area for placement of the Blocs. Figure 4 shows bank preparation using hand tools to form a level bench for placement of the

Blocs. Note the vertical nature of the stream bank wall. This is necessary to achieve maximum contact between the bank and the Blocs and minimize any large voids the flow could get behind and cause

Figure 4: Streambank excavation and preparation.

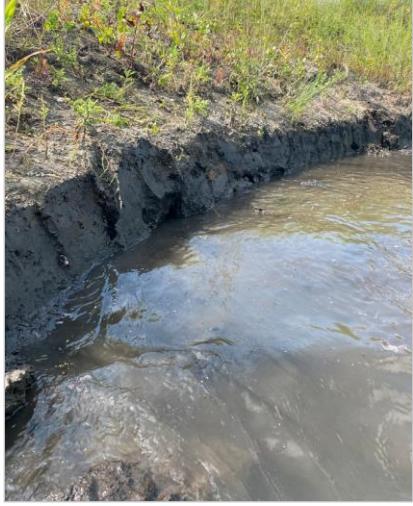
erosion. Figure 5 shows the bank area prepared for Bloc placement.

Figure 5: Restoration are ready for Block installation

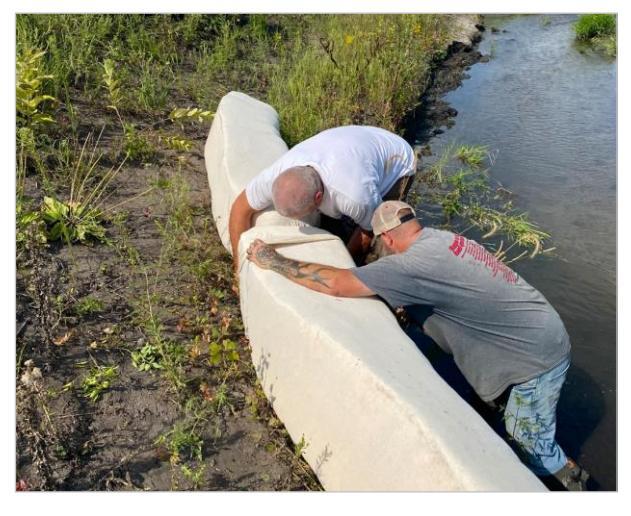
This step requires assembling Curlex[®] Bloc in 8' lengths. Each Bloc includes a sleeve at each end of the Blocs that needs to be fitted over the next Bloc to form the connected length for the restoration. Fitting the Blocs together was a bit challenging given the length and weight of the Blocs, however once they were lined up and butted together they formed a gapless joint between the Blocs. This step is optional, but does provide the best joint option. Figure 6 shows the Blocs being fit together with sleeves.

Figure 6: Fitting two Curlex® Blocs together.

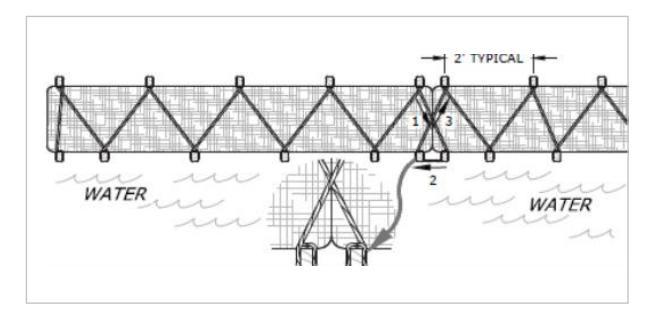
This step requires securing the Blocs into the excavated restoration area. The anchoring pattern requires 2 foot spacing with anchors placed on both sides of the Curlex[®] Bloc along the water face and bank face, driven a minimum of 2 feet into the ground. Figure 7 shows the anchor system installed. Once the anchor stakes are placed, rope was located per the anchoring techniques detail.

Figure 7: Curlex[®] Blocs anchoring detail.

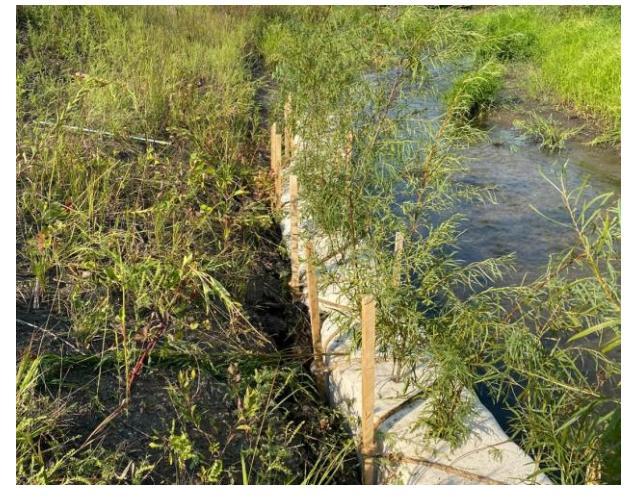
This step required placing live stakes along the length of the Bloc. Once these begin to establish root systems they will overtake the Bloc and form natural protection along the bank reducing future degradation of the bank. Figure 8 illustrates the planted Curlex[®] Bloc.

Figure 8: Curlex[®] Bloc with live stakes inserted.

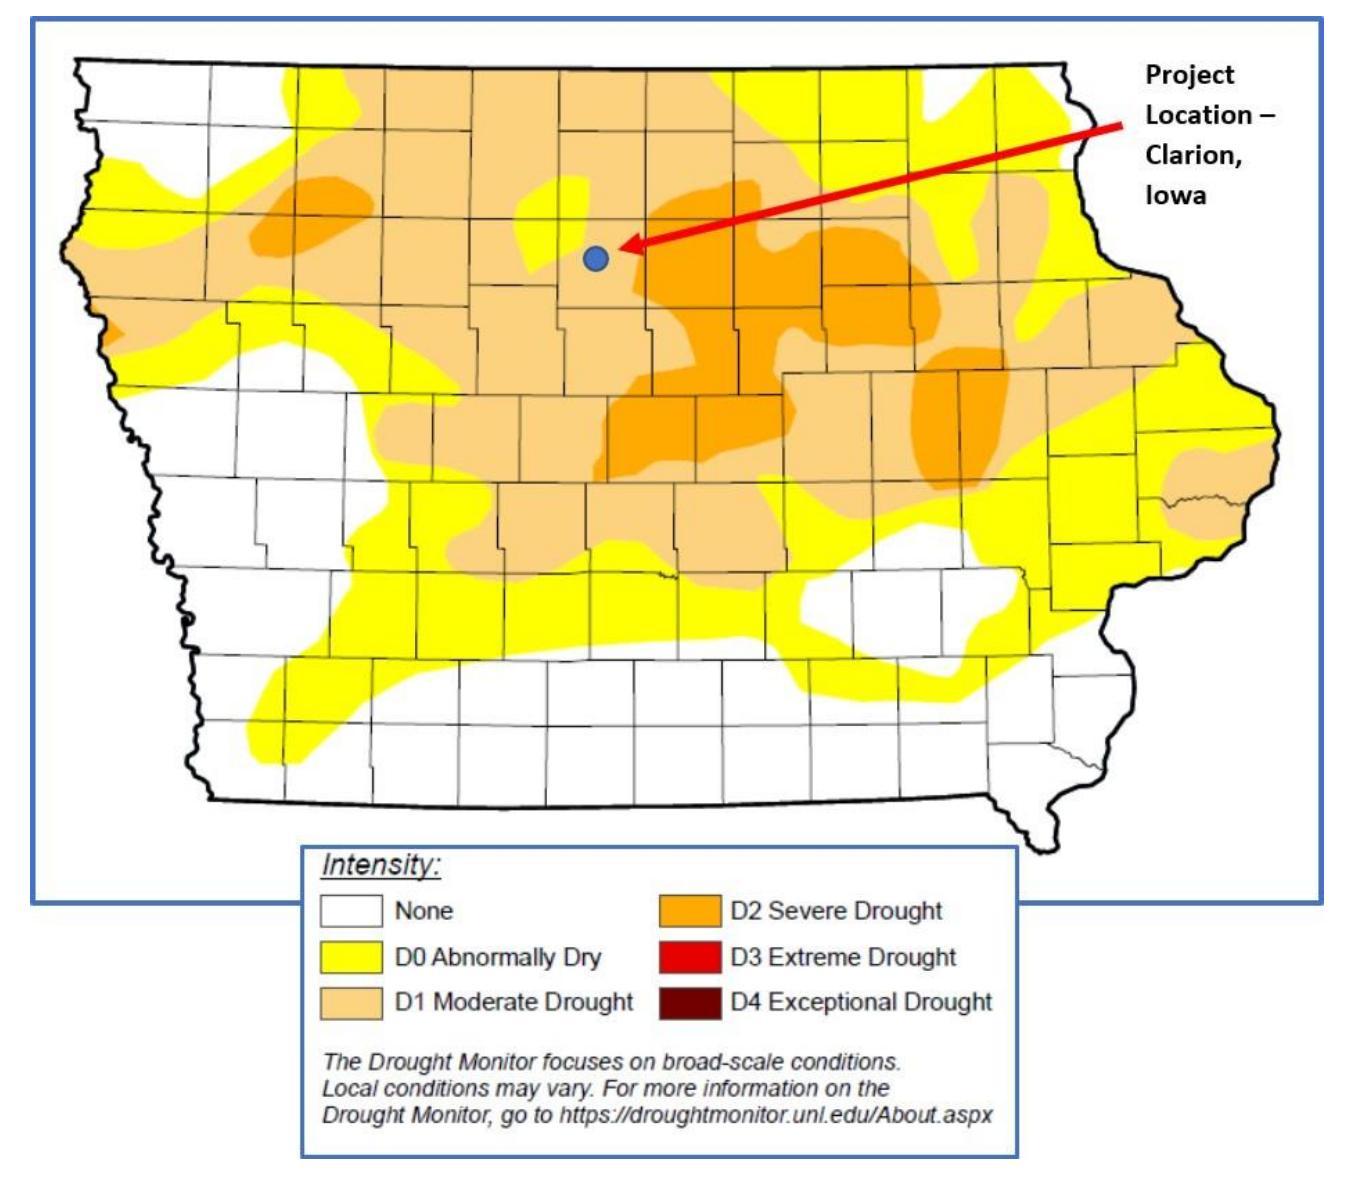
The restoration site in Clarion, Iowa has been experiencing abnormally dry to moderate drought conditions throughout 2021. Figures 9 and 10 are graphics developed using data and information from the US Drought Monitoring Center. They show drought conditions in Iowa on September 7, 2021 when the project was constructed and the drought conditions on October 5, 2021 prior to the field inspection to document vegetation establishment.

Figure 9: September 7, 2021 Drought Monitor Status for Iowa.

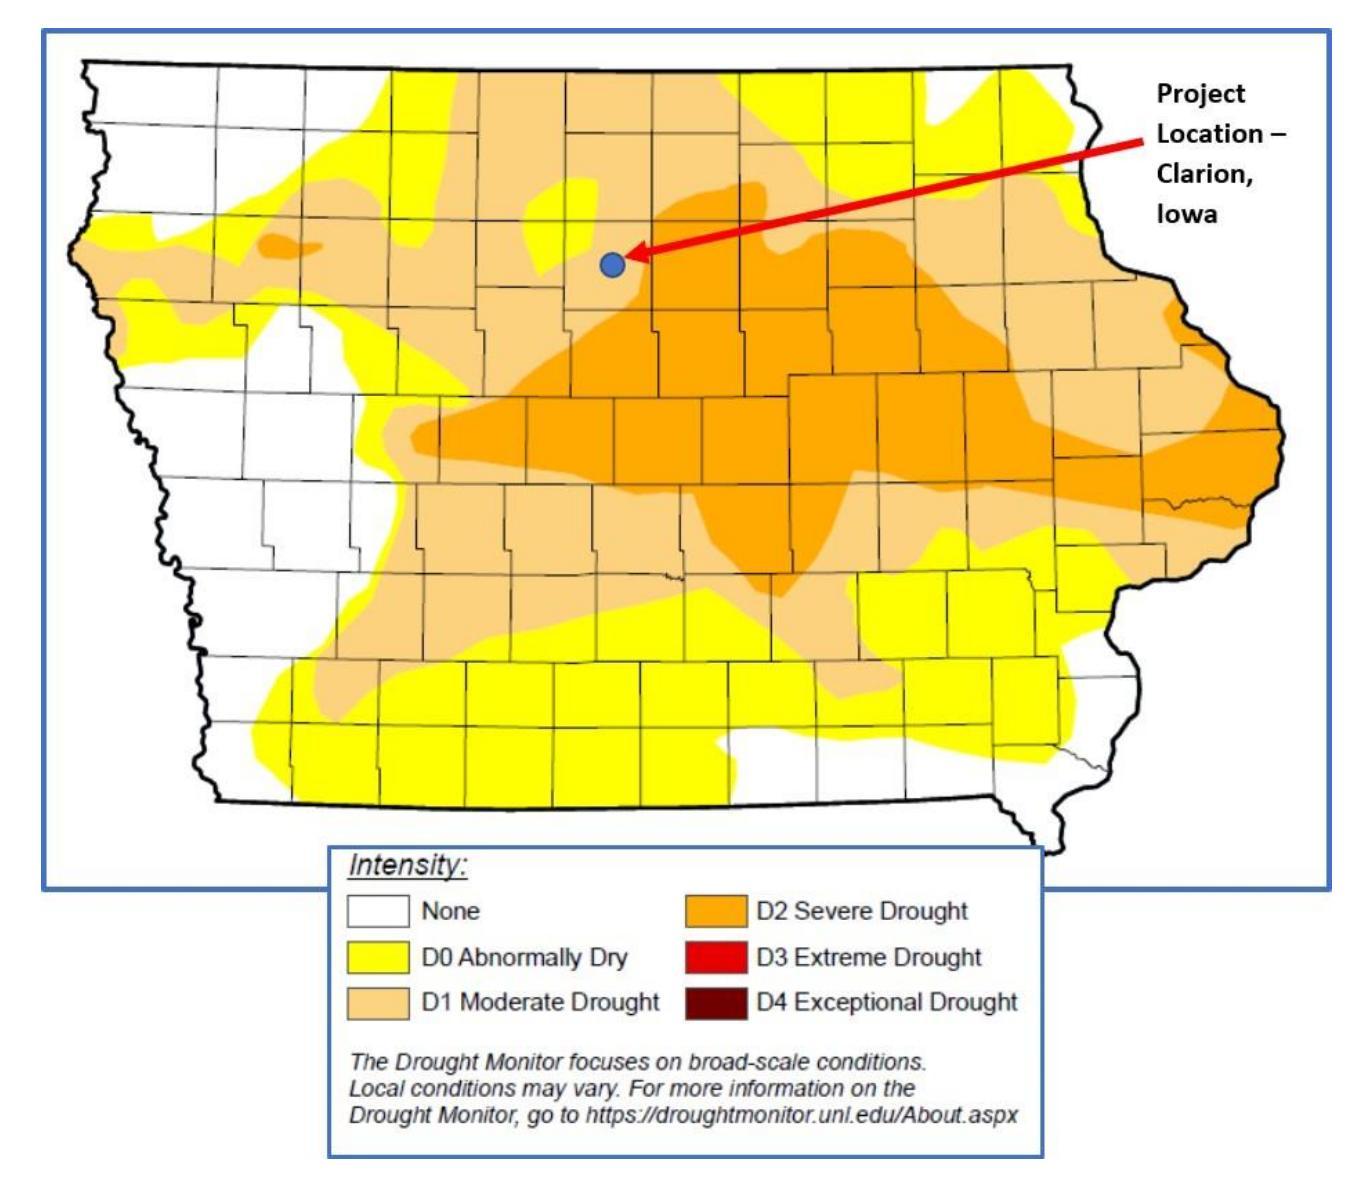
Figure 10: October 5, 2021 Drought Monitor Status for Iowa.

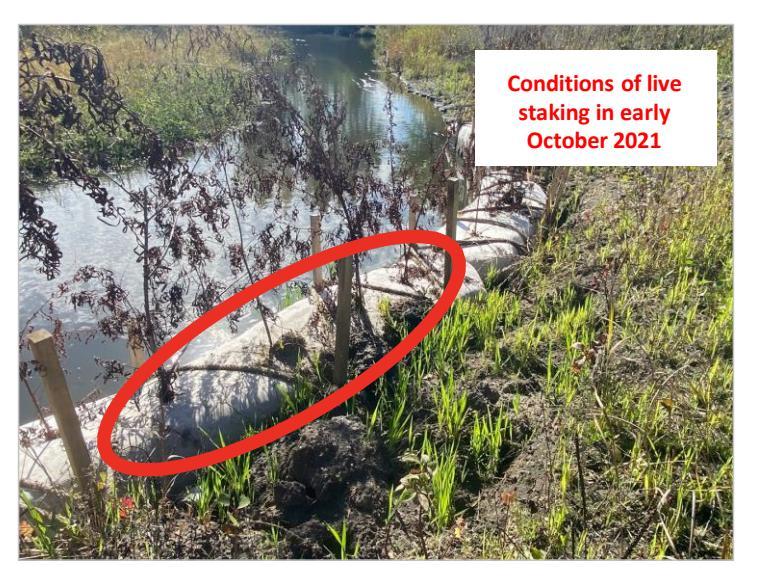
Figures 11 and 12 show the condition of the live staking as it looked during the October 5, 2021 field inspection. There are several items worth noting in the figures:

- Note the condition of the live staking.
- Note the establishment of vegetation in front and behind the Curlex[®] Blocs.
- Note the change in stream water level from the installation in early September to early October.

Figure 11: Vegetation establishment behind Blocs and live staking.

- New vegetation was noted in the stream in front of the Blocs and also behind the Blocs along the bank. If needed, additional live staking will be added in the spring of 2022.

- Post-installation lesson learned: JEO should trim down the tie-down stakes to minimize any debris from collecting on them during high flow events. This will also reduce the risk of wildlife becoming injured on the tie-down posts.

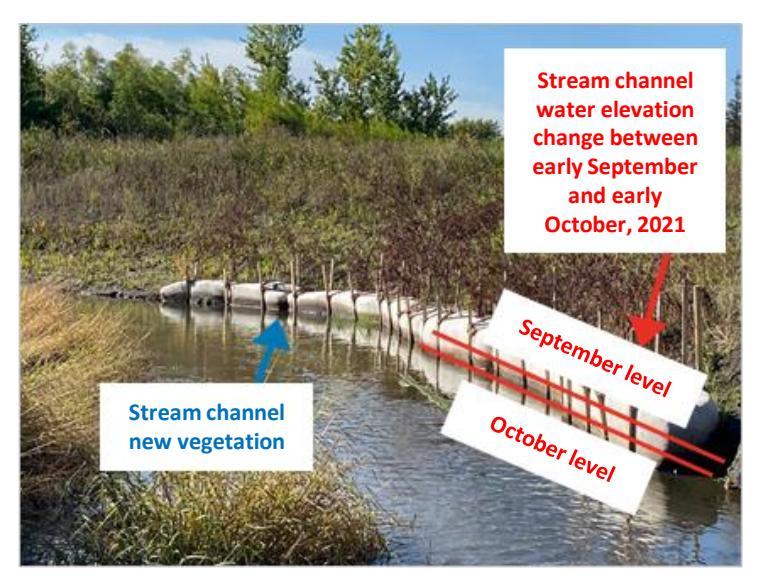
Figure 12: October 5, 2021 Water level change and vegetation growth in the channel.
