Enforcing Soil in Place

Steep, long slopes and erosive loess soils do not add up to ideal conditions for post-construction erosion and sediment control measures. These exact harsh conditions were encountered and mastered at a construction site located in Sioux City, IA. Proper planning, design, and product selection coupled to produce an impressive erosion control and revegetation project.

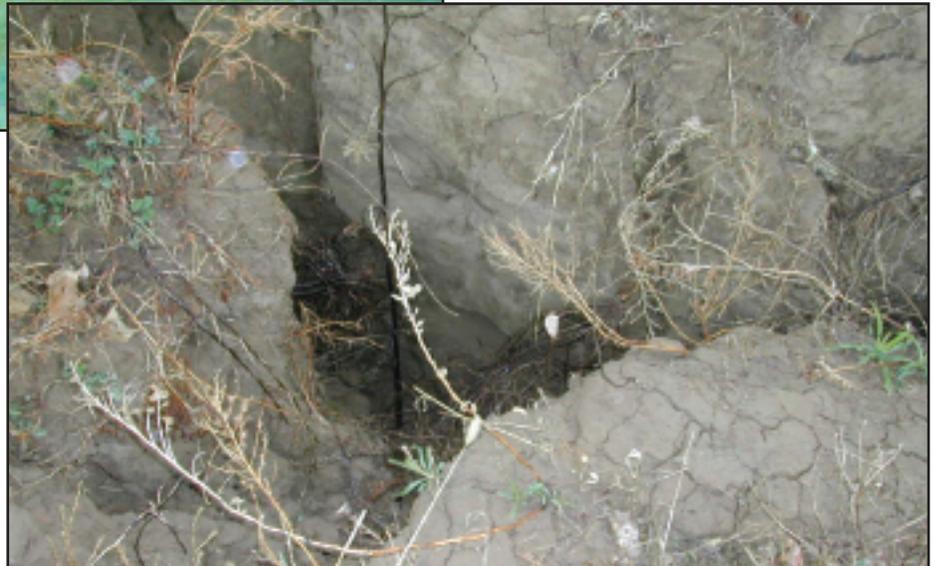
Top photo: Composite turf reinforcement matting installation. Bottom photo: Erodible onsite loess soils.

conditions. The AEC team recommended Curlex® Enforcer® QuickGrass® for the site. The product is a composite TRM, which contains dyed-green excelsior wood fibers and heavy duty, UV-stabilized polypropylene netting in a blanket-like configuration that provides surface cover to reduce erosion and hasten vegetation establishment. It was selected for the project based on the following four facts: 1.) Anticipated hydraulic forces would not require the performance level of the original product specified. 2.) Wood fiber biodegradable component enhances vegetation establishment better than long-term biodegradable matrices. 3.) Cost of erosion control materials would be reduced, while obtaining equal or better results. 4.) Green color of the product provides a finished look until vegetation becomes established. In addition, the project team liked the fact that the product provides permanent reinforcement to the vegetation.

Before the erosion control products were installed, six inches of topsoil material were spread across the graded slopes to help combat the highly erosive native loess soils. All disturbed land was seeded with native grasses and wildflowers. Oats were also included in the seed mixture to provide a quick cover. An eight man crew was used to install the erosion control products on site. The crew protected the top of the slope first and worked their way down to the toe of the slope. Nearly 50,000 yd² of the composite TRM material was installed to protect the slopes at the project.

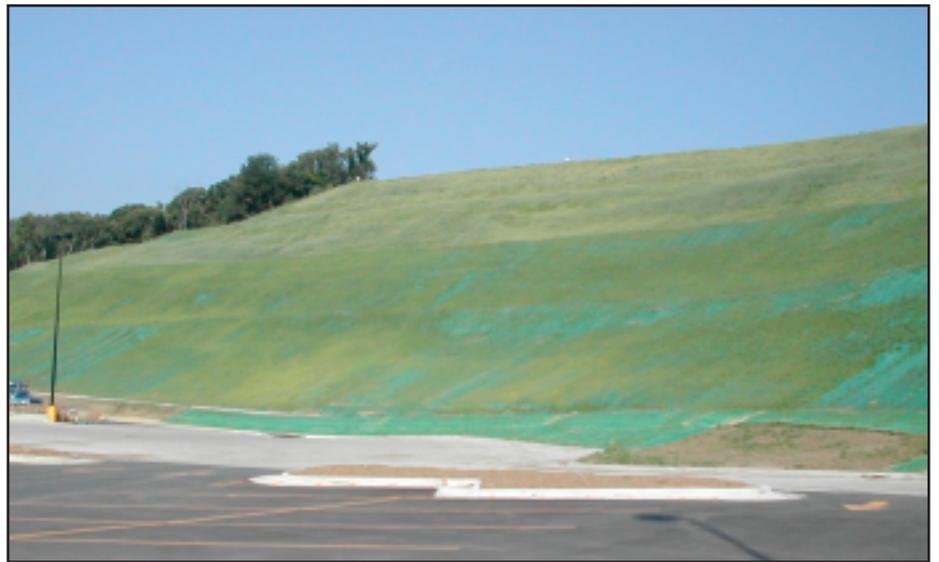
Protected slopes shortly after the completion of installation.

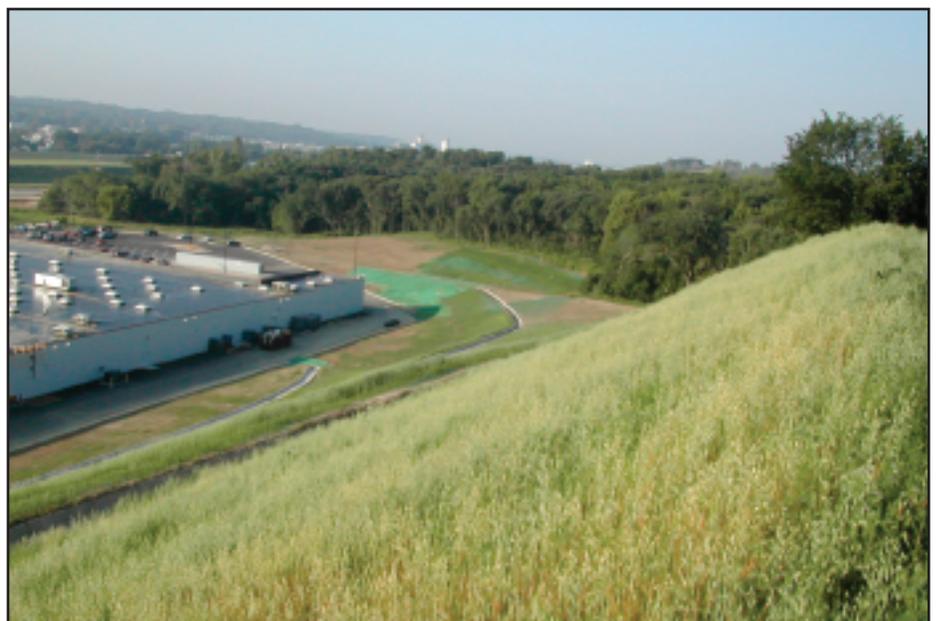
Plush, aesthetic vegetation now covers the once feared slopes.

Today, the system of benches and composite TRMs is an aesthetic, successful erosion control solution. The store and parking lot below the massive slope are permanently protected because the project team devised and executed a perfect erosion and sediment control plan.
